Historic
Preservation
Commission

The City-County of
Butte-Silver Bow

5:30 p.m. Tuesday
February 4, 2019
Council Chambers
3rd Floor Courthouse
155 W. Granite

Project Title: 615 - 617 ½ North Excelsior Apartment Building Rehabilitation

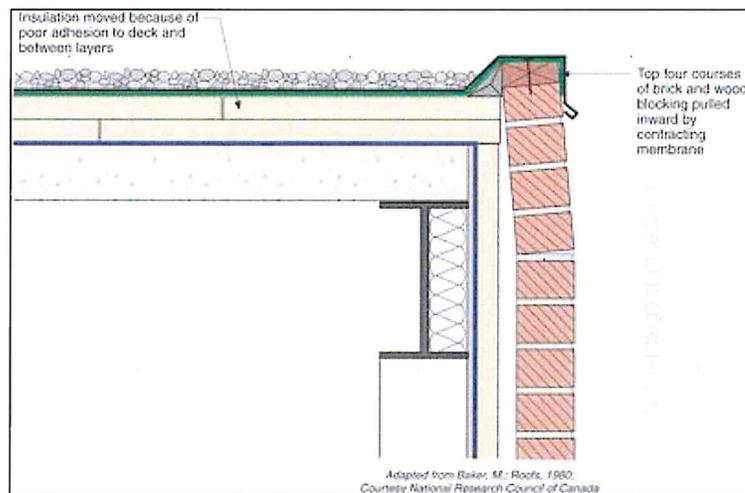
unstable. Figure 1 shows this phenomenon and was downloaded from the Building Science Corporation website (<https://buildingscience.com/documents/insights/bsi-050-parapets-where-roofs-meet-walls>). This figure shows a membrane roof but the tar along the inside of the Excelsior building roof is acting in a similar fashion to the membrane shown in Figure 1.

Figure 1. BSI-050 – Parapets – Where Roofs Meet Walls.

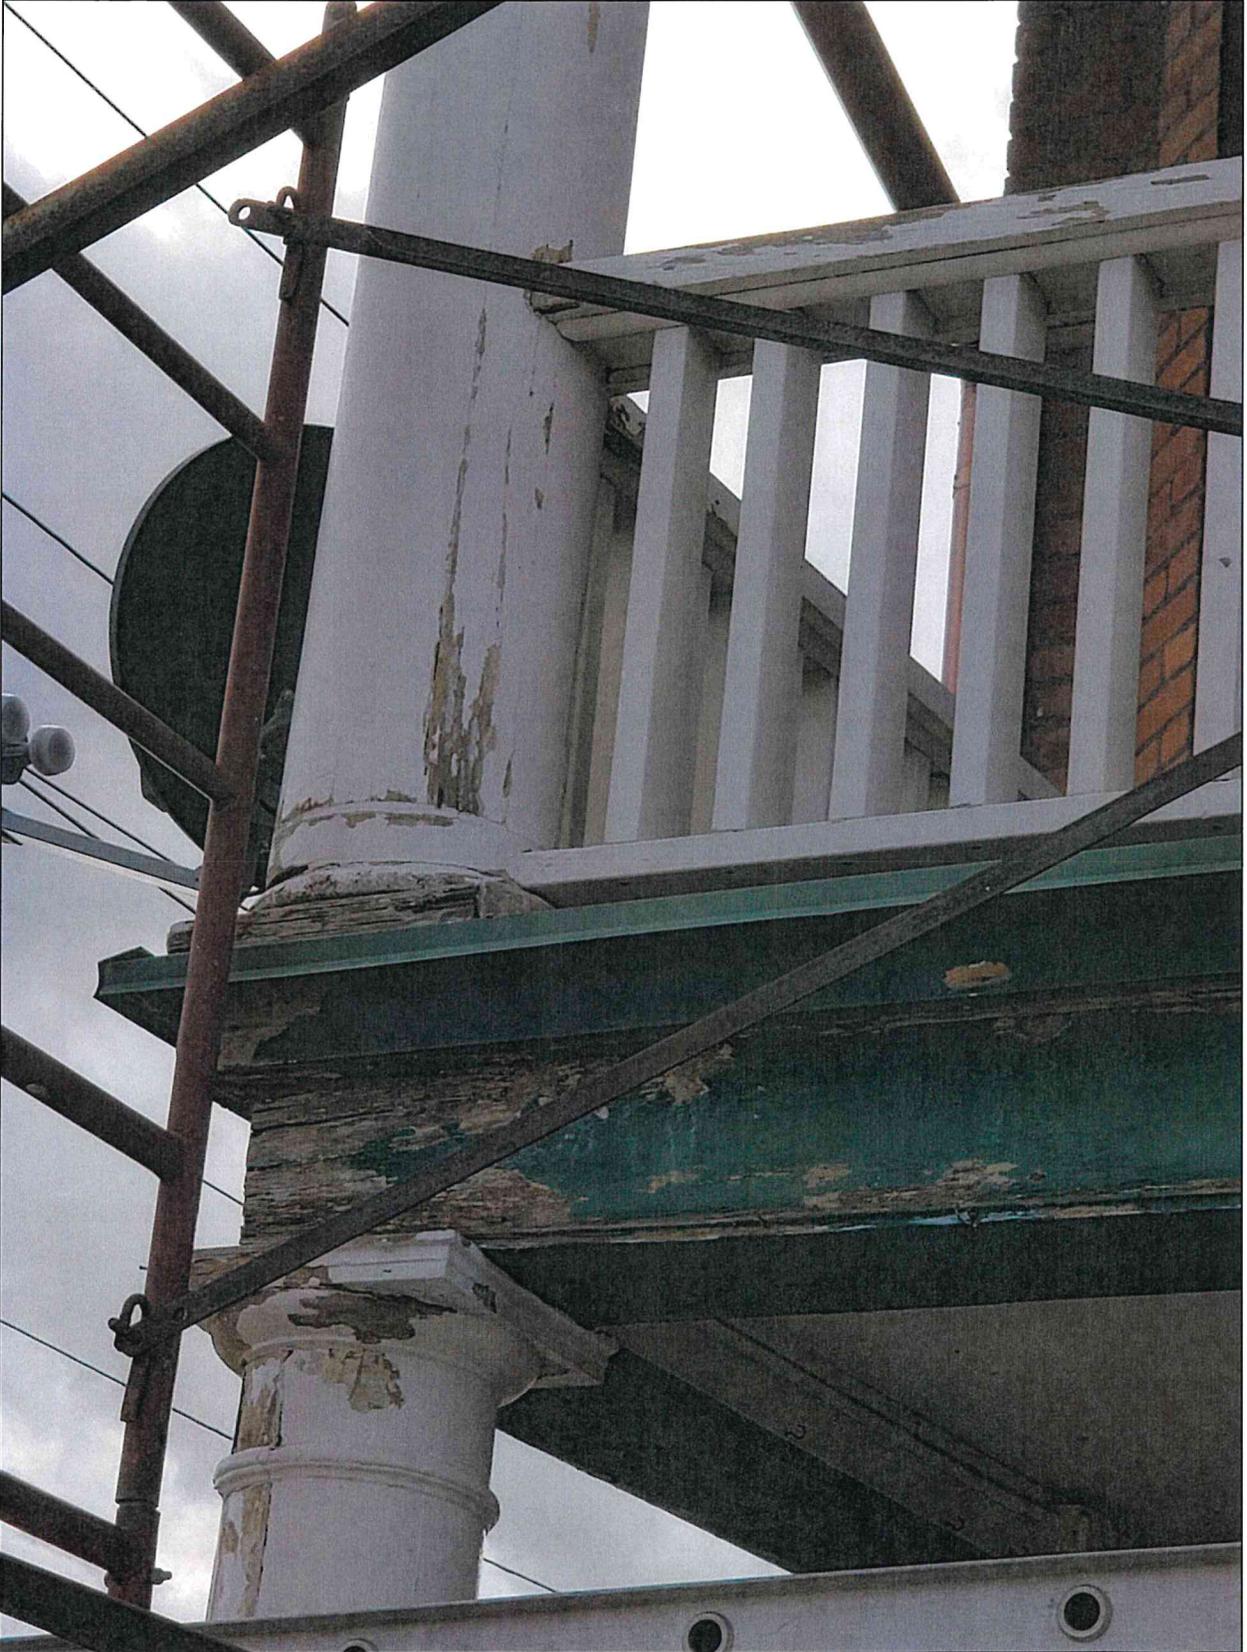
Figure A1. Water damage from old gutters on south columns and front porch face.

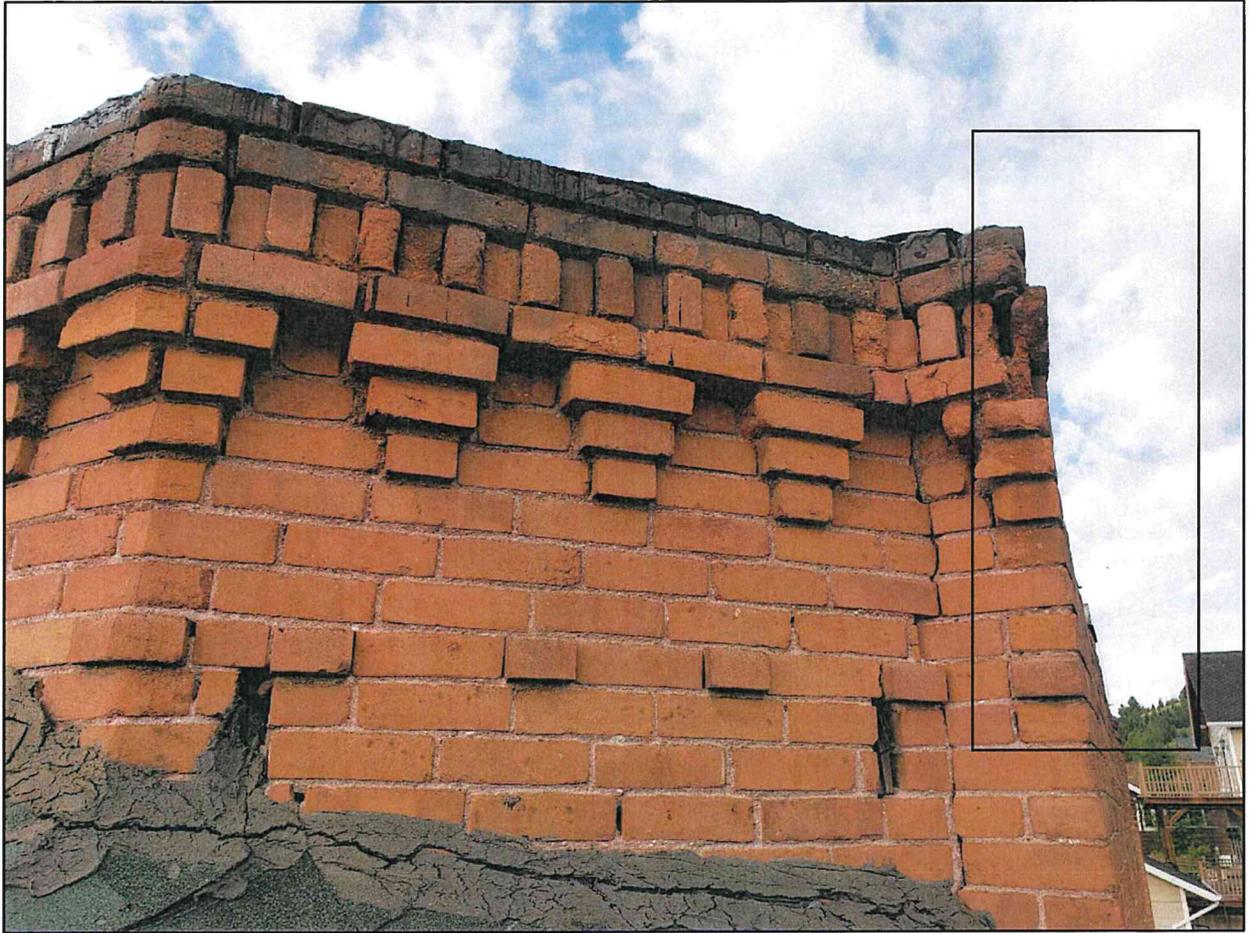
Damage from previous tar roofing efforts resulted after tar was applied to the bricks along the inside surface of the roofline above the tarred roof. Because of this, the bricks are being pulled inward toward the roof making it even more

Figures A2 and A3 in Appendix A show this damage on the Excelsior property. When viewing these pictures one can easily see the extensive damage and cracking to the top ten brick courses of the building on the northeast corner section.

Figure A2. Northeast corner section of brick parapet.

- Remove and clean parapet brick approximately 1½ feet down along entire perimeter of building (observed brick parapet pulled in from roofing),
- Reinstall historic brick with historic mortar mix (type k low compression) on outer face of building,
- Inside parapet towards roof, install cmu block for backing for outer brick support (outer brick tied to cmu block),
- All material, scaffolding, equipment, labor, cleanup, for repair of parapet brick work,
- Match color of existing mortar, and
- Install counter flashing on east facing wall (porch roof meets brick) to prevent water damage.

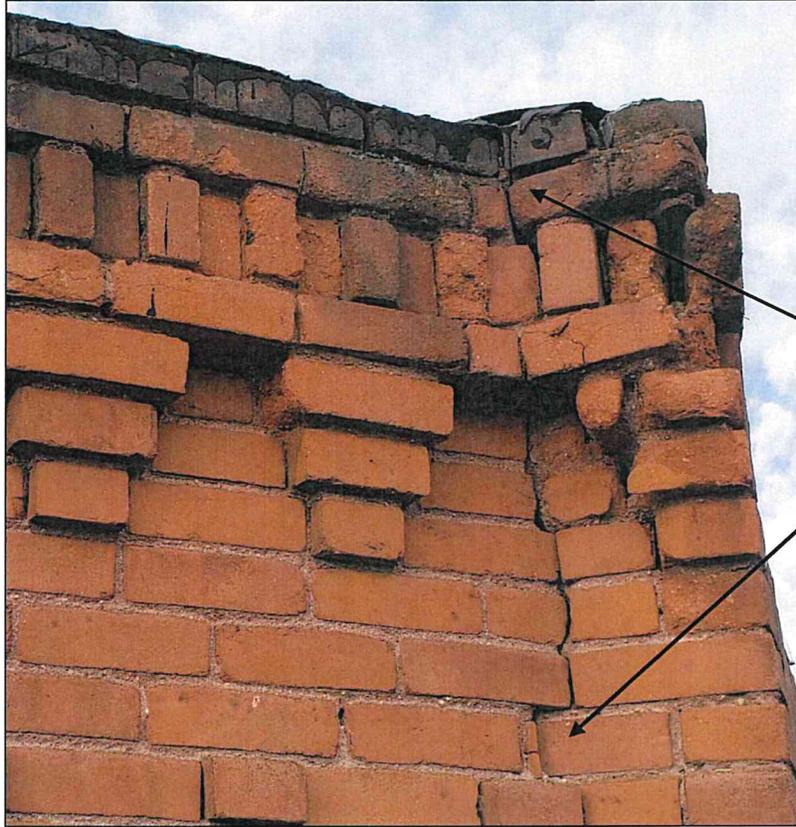
Figure A3. Close-up of NE corner of brick parapet section.

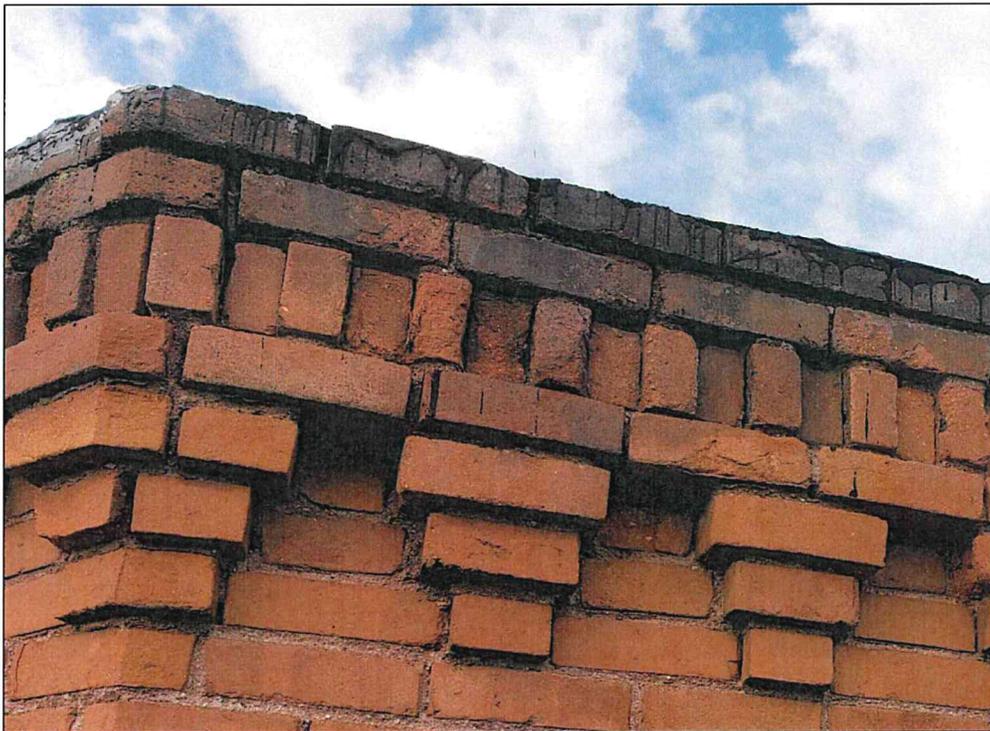
Figure A4. Close-up of NE brick parapet section.

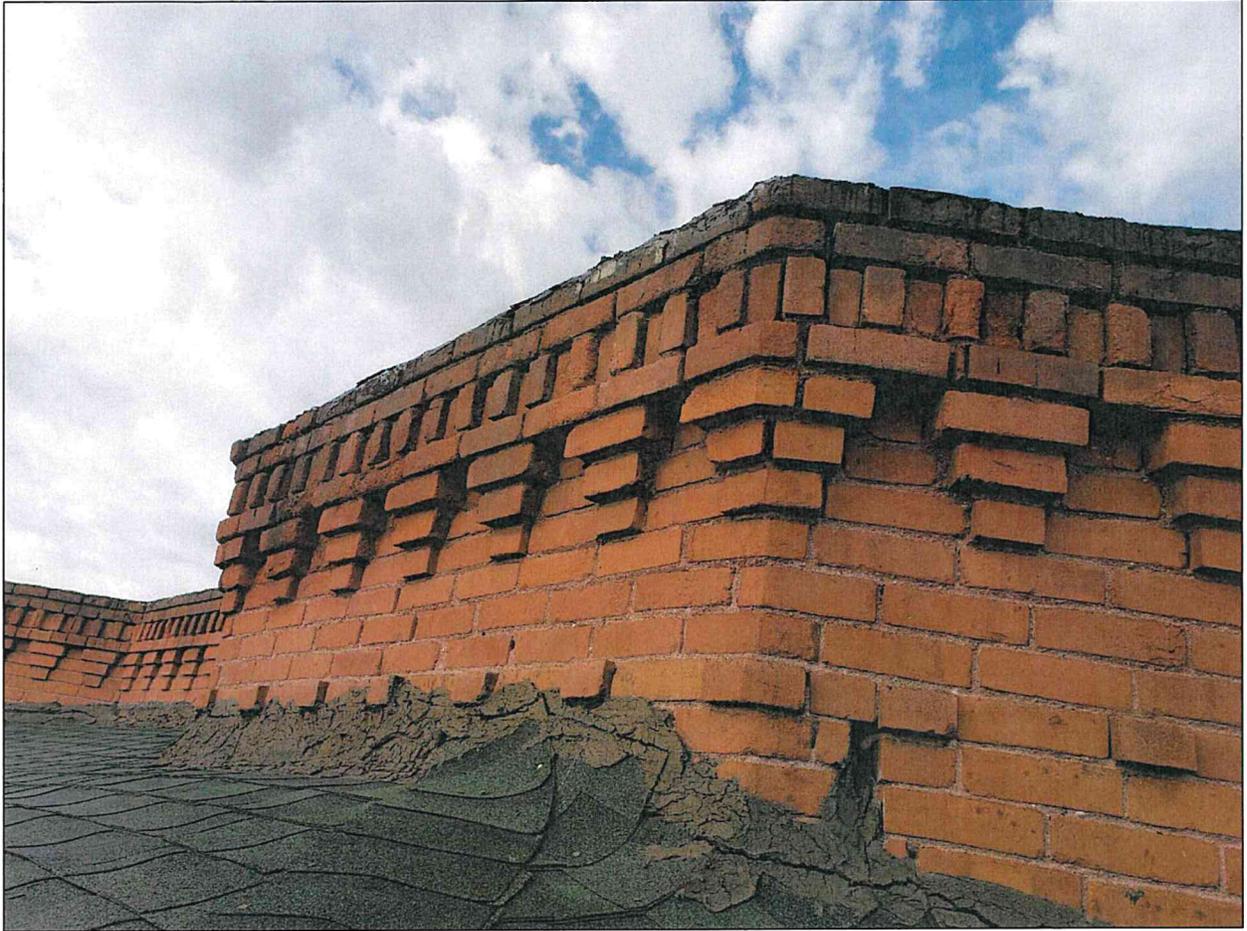
Figure A5. Northeast Front section of brick parapet showing shingles on front porch roof.

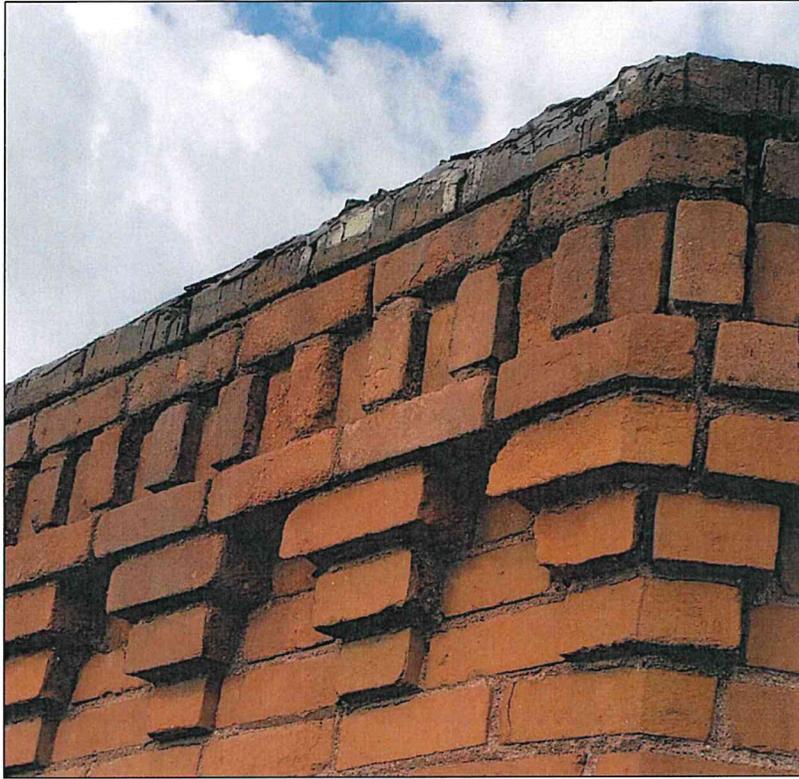
Figure A6. Close-up of corner NE front section of brick parapet.

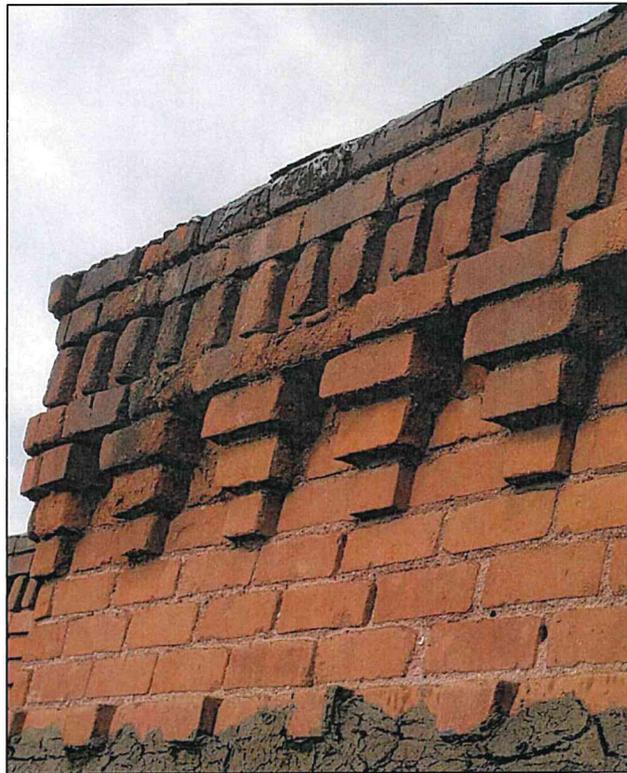
Figure A7. Close-up of NE front section of brick parapet.

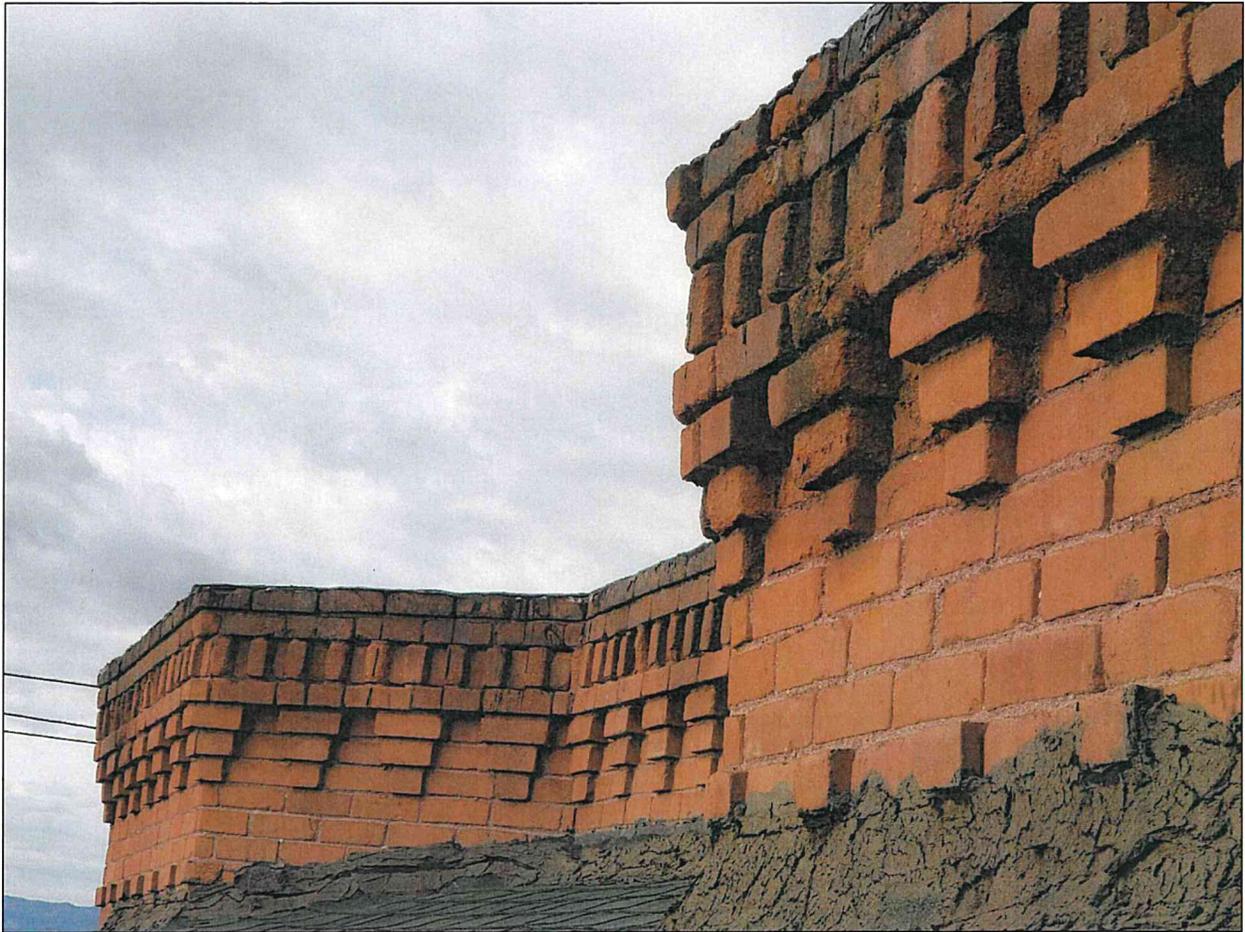
Figure A8. Southeast section of brick parapet shown on left hand side of photo.

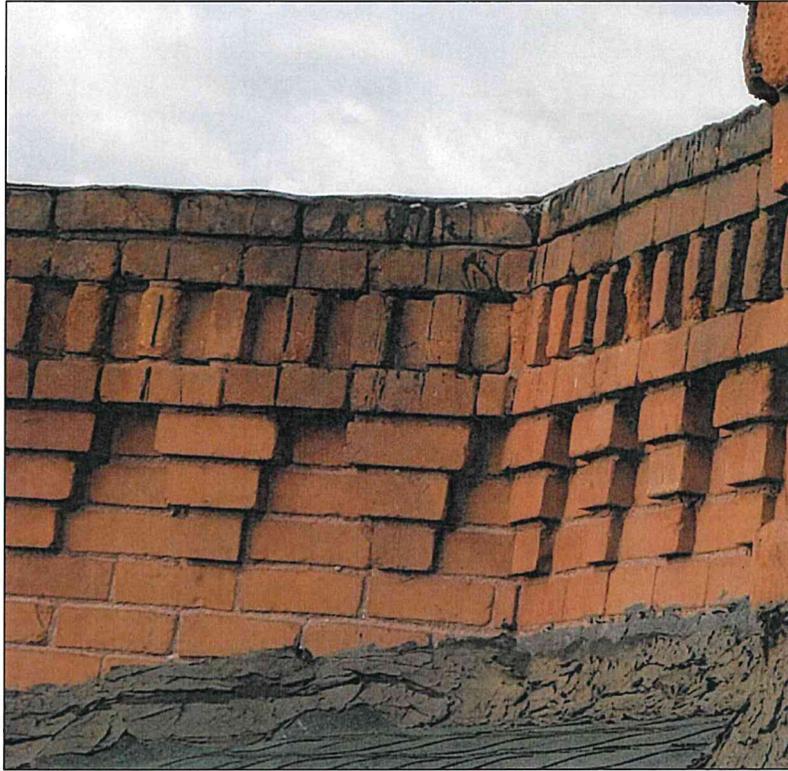
Figure A9. Close-up of SE section of brick parapet.

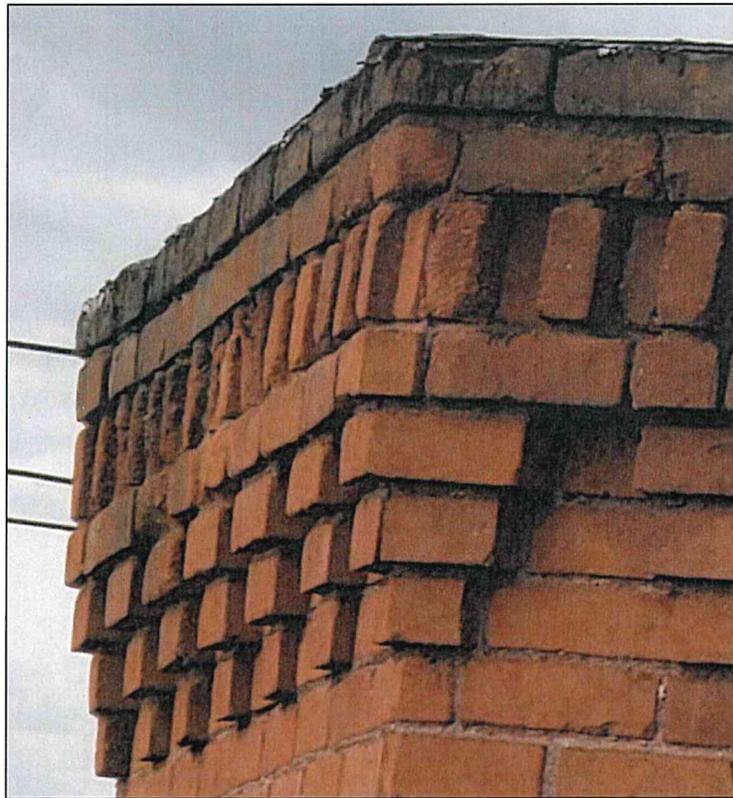
Figure A10. Close-up of south corner of SE section of brick parapet.

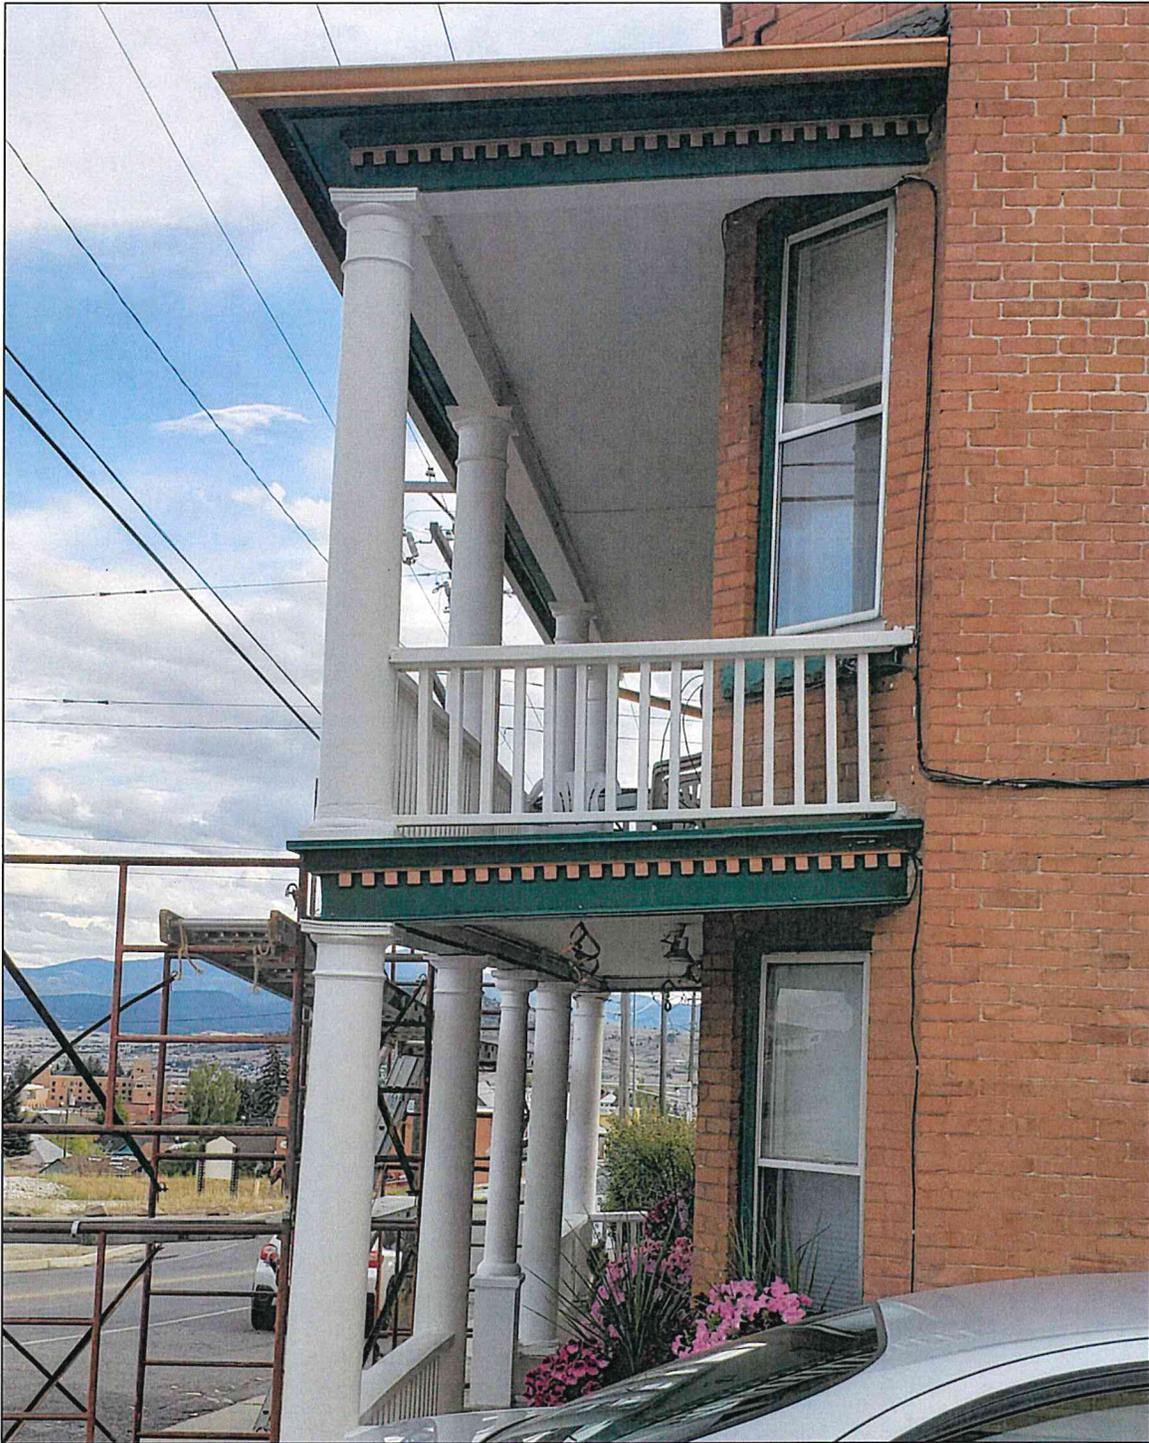
Several years ago, a van ran into the building destroying one of the bottom columns as well as a bannister section and brickwork on the north side of the front lower porch. The historic bay-fronted window was saved as well as the front entry door glass. After contractors finished repairing the damage, she and her brother jacked up the front porch and replaced the new column top with the old one to ensure it matched the rest of the existing column tops to keep the historical features of the building intact.

Figure A11. North side of Apartment Building during porch restoration in summer of 2019.

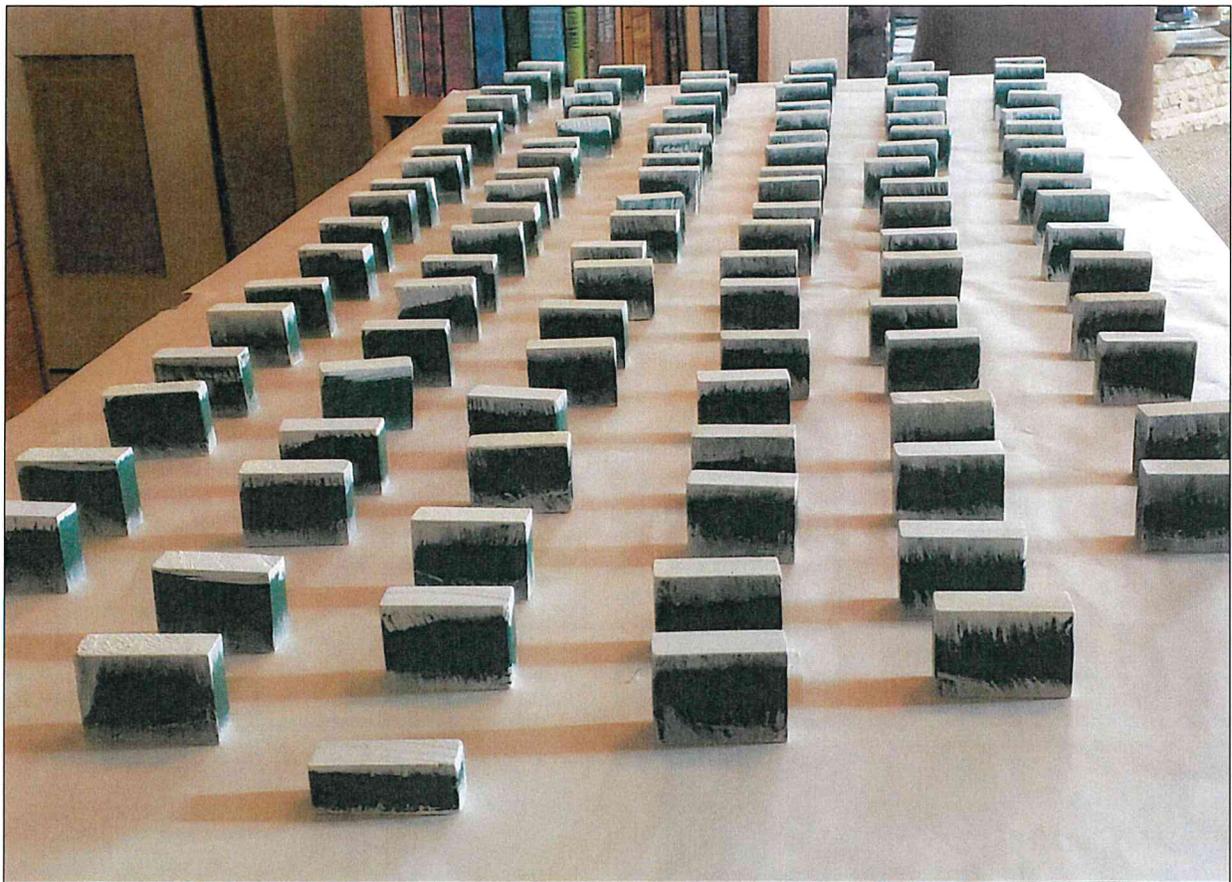
The historical dentil molding exists on five of the six porch faces. Sometime before Ms. Bickford purchased the building, the dentil molding blocks were removed from the lower front porch face. She searched for matching dentil molding during the porch restoration this summer but could not find anything was even close to her building's design. So over one hundred blocks that measured 1-7/8 inches by 2-1/8 inches were cut, sanded, primed and painted green. The weather prevented Ms. Bickford from completing the dentil molding restoration and accent painting on the remaining four front porch faces. A picture of the dentil blocks during the painting process is presented in Appendix A.

Figure A12. Dentil blocks for lower porch front face during painting process.

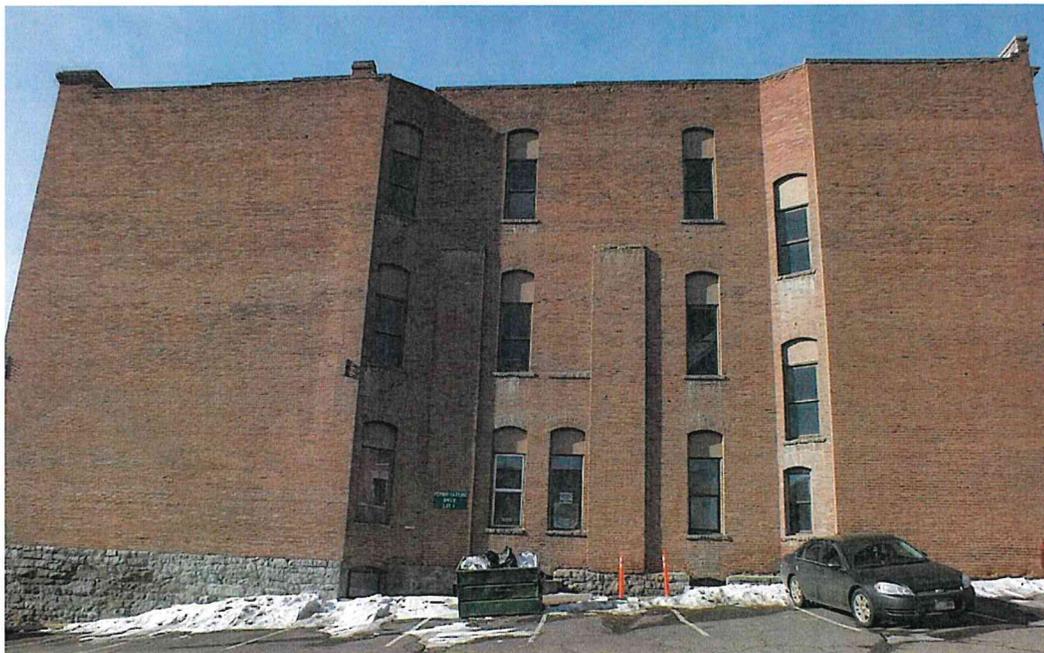
Masonry work will involve repairs to sections of deteriorated brick wall below three of the rebuilt windows (2 on the east side and 1 on the west side). Displaced brick will be reset. The new mortar will replicate the original in composition, texture, and color. This work will be performed by Clark Grant and Daniel Hogan, who gained considerable expertise in historic masonry repairs while rebuilding the brick parapets at the 1880s Caplice & McCune Mercantile in Walkerville.

East façade. Two window rebuilds proposed at this time.

To be performed by woodworker and journeyman patternmaker, Jay Bressette, work will involve constructing, glazing, and installing 12 new 1/1 wood-sash double hung windows, all with a single pane transom. The new windows will be of the same size as the originals, and their wood sashes will replicate the original sashes in dimension, profile, moldings, and other details. Hardware will be salvaged from the original windows and reused in the new. Additionally, the original pulleys for raising and lowering the double-hung sashes will be repaired and reused.

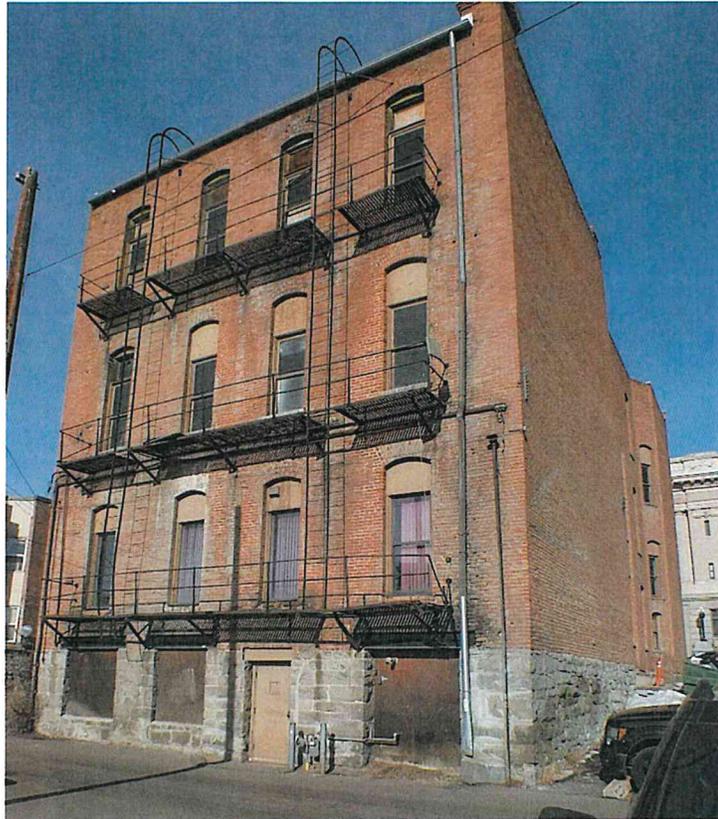
South (rear) façade. Eight window rebuilds proposed at this time.

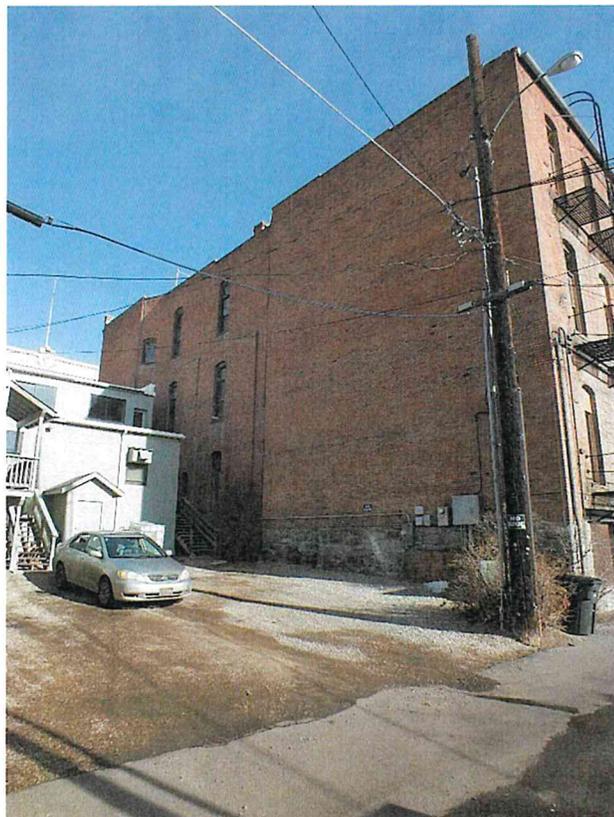
West façade. Two window rebuilds proposed at this time.
