**EMERGENCY ACTION PLAN
STORM LAKE DAM
BUTTE-SILVER BOW
DEPARTMENT OF PUBLIC WORKS
WATER UTILITY DIVISION
124 WEST GRANITE STREET
BUTTE, MONTANA 59703-0667
(406) 497-6540
January 2019**

APPENDIX B
INUNDATION AND EVACUATION MAPS

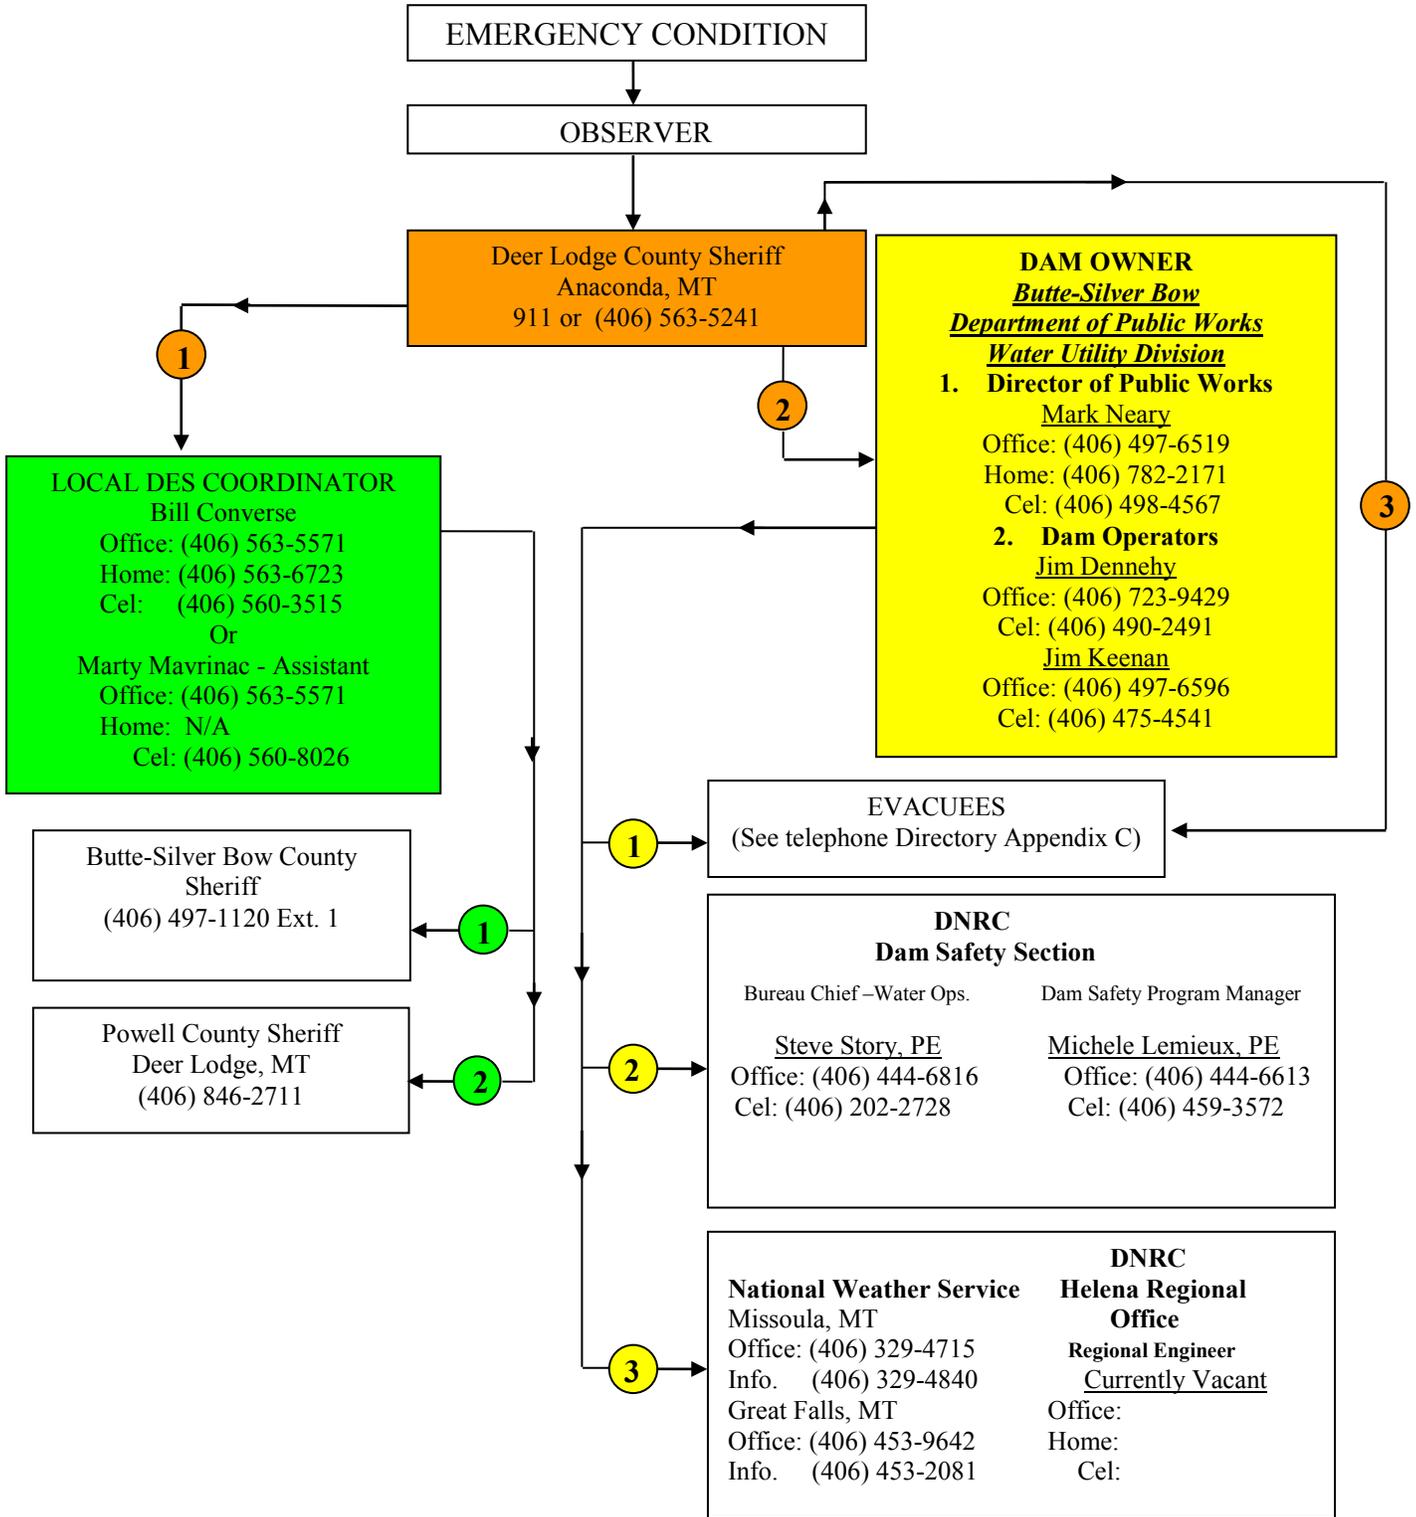
**FIGURE 1
STORM LAKE DAM
ACTUAL OR IMMINENT FAILURE
"NOTIFICATION FLOWCHART"**

If assistance is required to evaluate if a dam is threatened with imminent failure, advice can be sought from the Dam Safety Section of the Department of Natural Resources and Conservation (DNRC). If Storm Lake Dam is failing, two things must be done immediately: (1) the hazard area downstream from the dam must be evacuated, and (2) any steps that might save the dam or reduce damage to the dam or hazard area downstream should be taken. (Refer to the map in Appendix B to determine the areas that are likely to be inundated if the dam fails). The evacuation will be handled according to the county warning plan, and should be initiated as shown in Figure 1.

The Notification Flowchart is posted at the dam and a copy of the EAP is posted at the dam site. The Anaconda- Deer Lodge County Police Dept. and the DES Coordinator have copies of the plan.

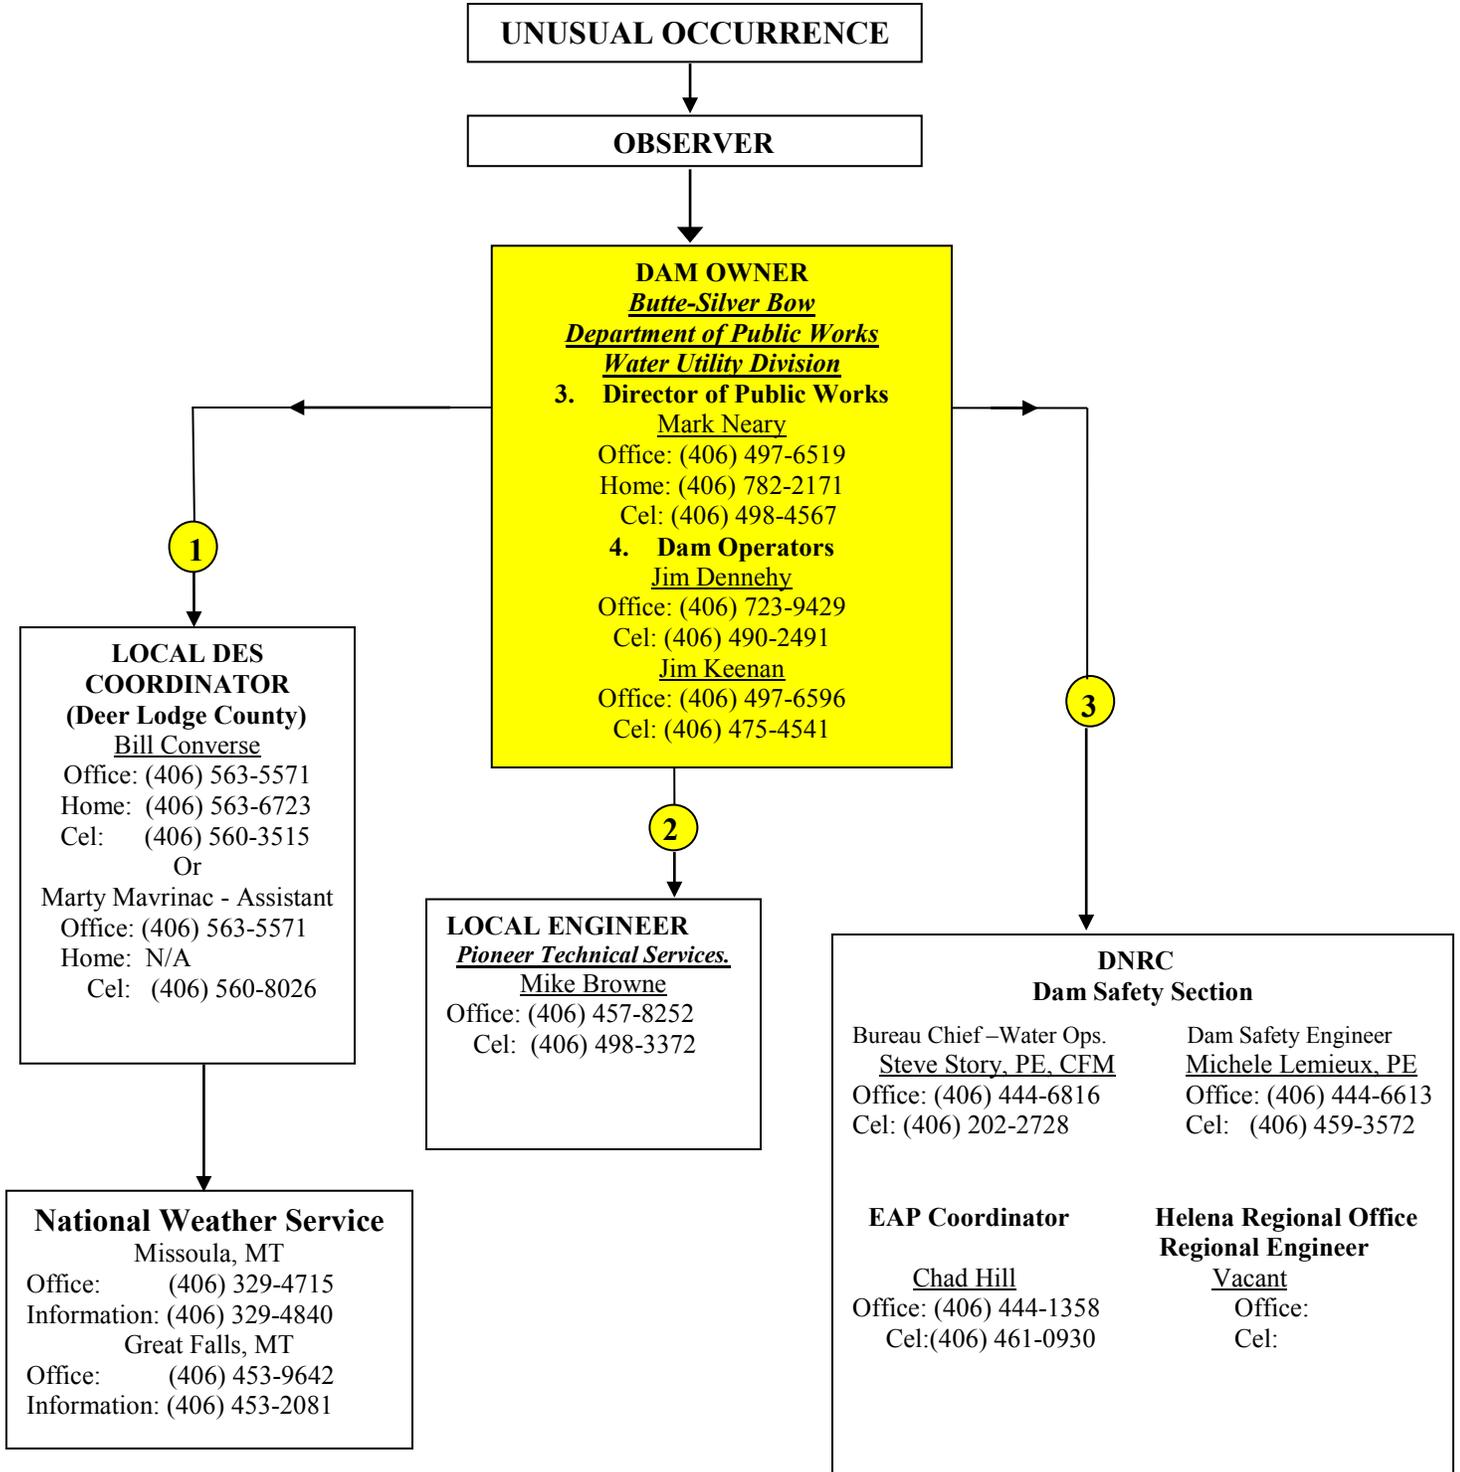
**FIGURE 2
STORM LAKE DAM
POTENTIALLY HAZARDOUS SITUATION
"NOTIFICATION FLOWCHART"**

A potentially hazardous situation is an event or condition not normally encountered in the routine operation of the dam and reservoir. Among the unusual occurrences that may affect the dam are dam embankment problems, failure of the outlet works, heavy precipitation or rapid spring snow melt, landslides, earthquakes, erosion, theft, vandalism, acts of sabotage, and serious accidents. These occurrences may endanger the dam, the public, or the downstream valley and may necessitate a temporary or permanent revision of the dam's operating procedures. Help in these situations can be obtained by notifying those people shown in Figure 2.

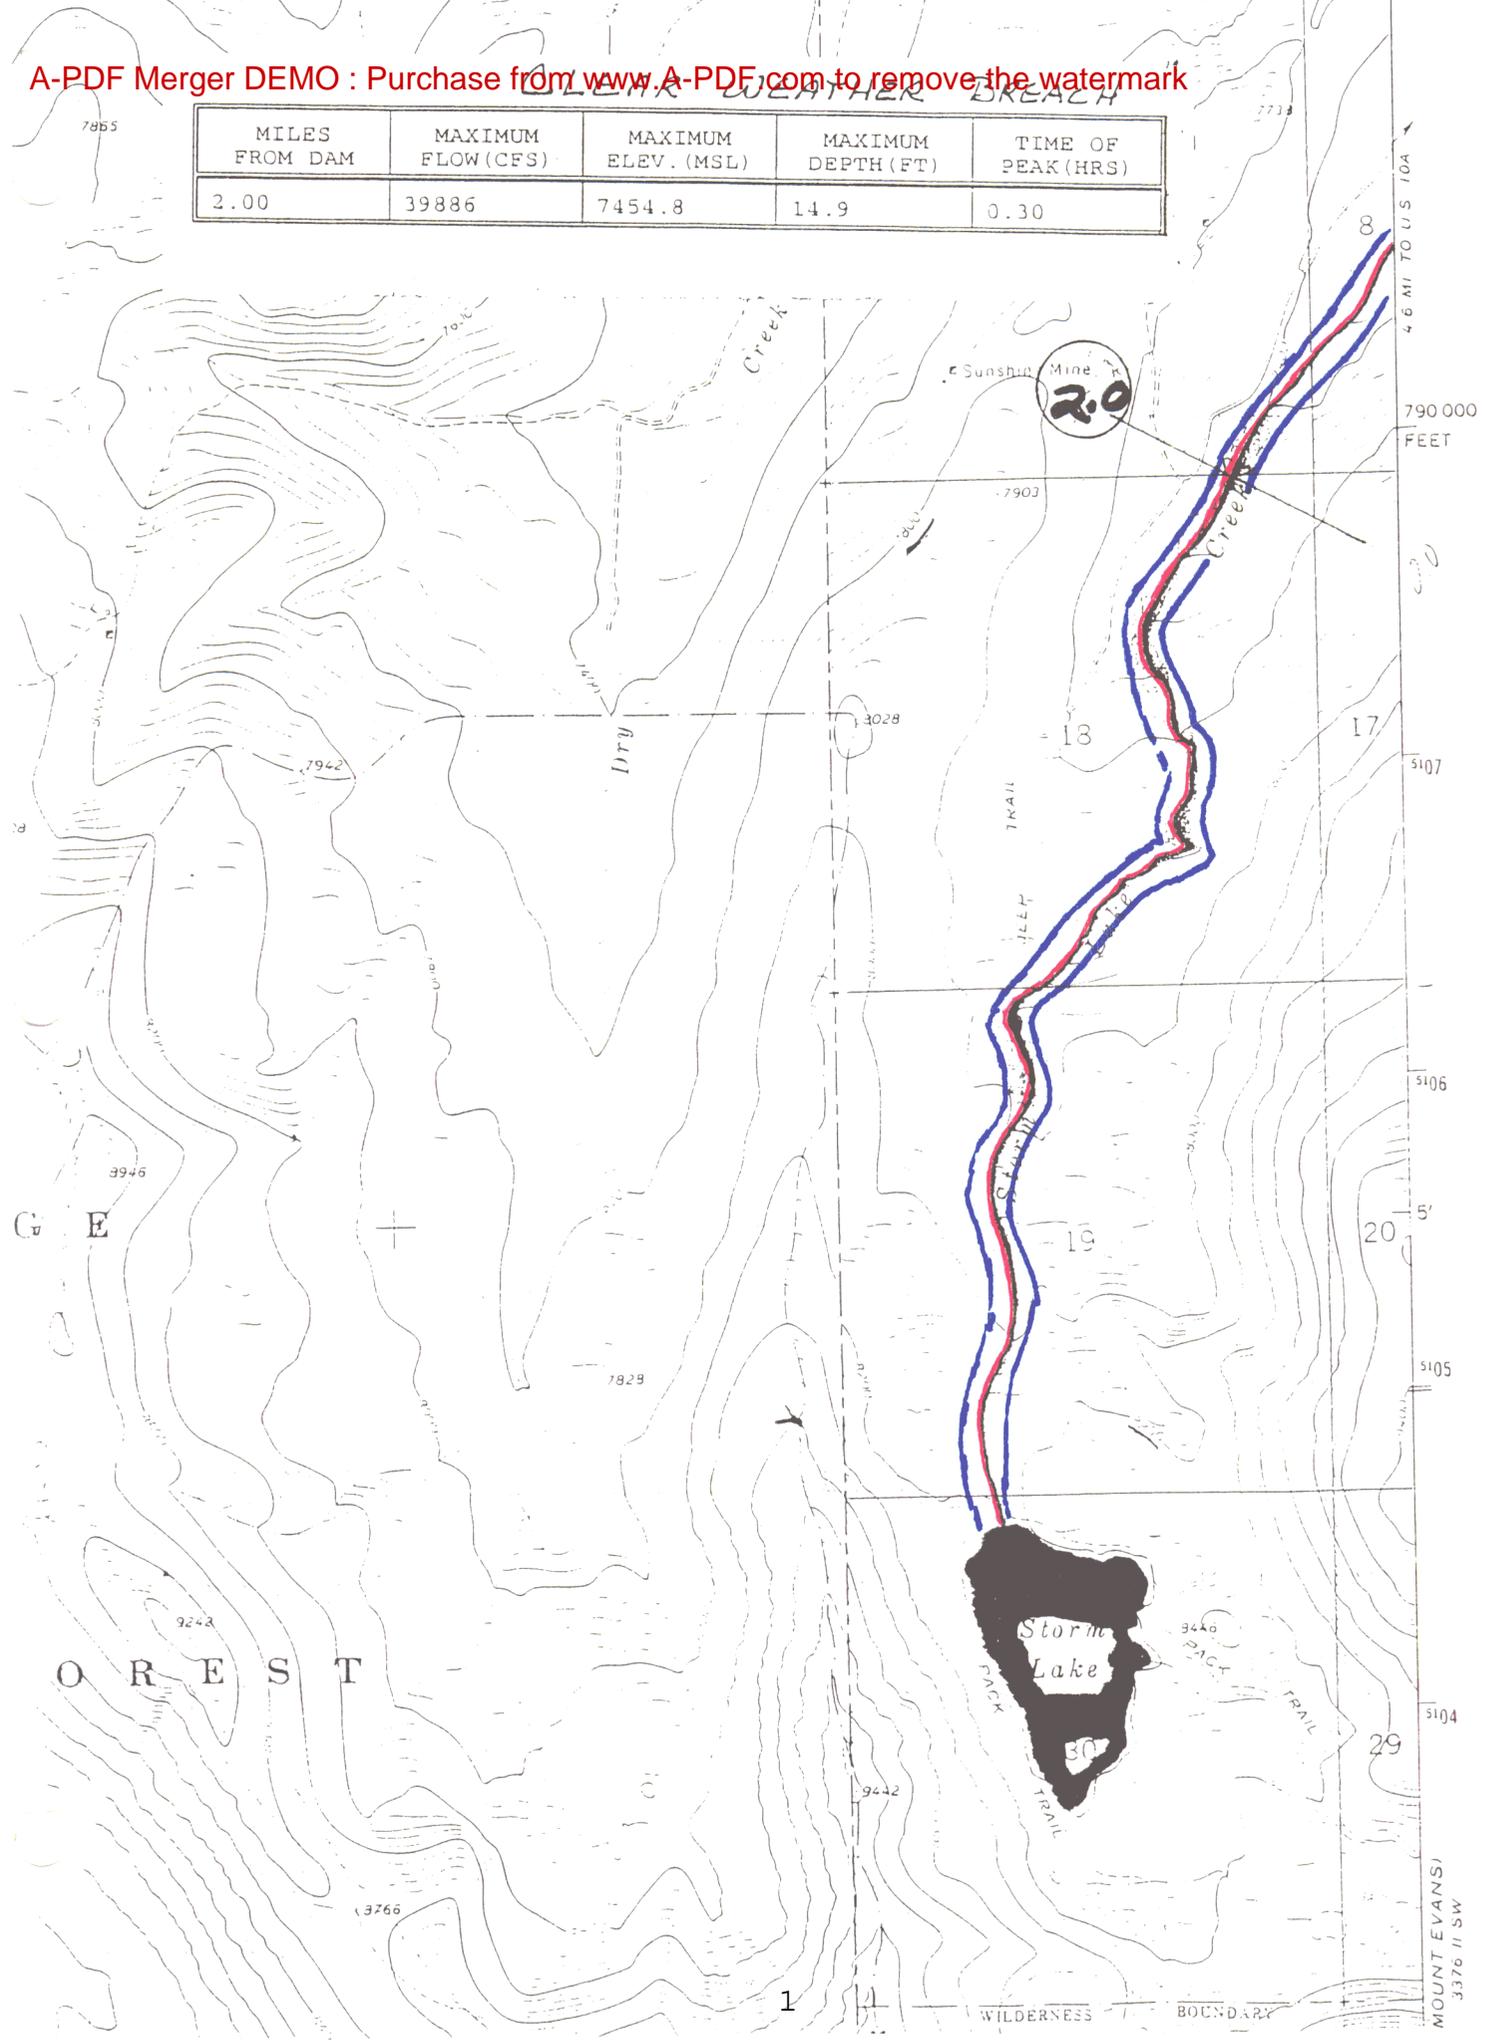
MILES FROM DAM	MAXIMUM FLOW (CFS)	MAXIMUM ELEV. (MSL)	MAXIMUM DEPTH (FT)	TIME OF PEAK (HRS)
2.00	39886	7454.8	14.9	0.30

The hazard area extends downstream from Storm Lake north along the Storm Lake Creek drainage northeasterly to the confluence of the Silver Lake discharge channel and thence easterly and passing under Highway 10A into Cable Meadows where it joins Cable Creek. From Cable Meadows, the inundation zone passes under the highway again and follows along the southern edge of the highway easterly toward West Valley and Anaconda, Montana passing under the highway three more times before reaching Anaconda. Inundation and evacuation maps are in Appendix B.

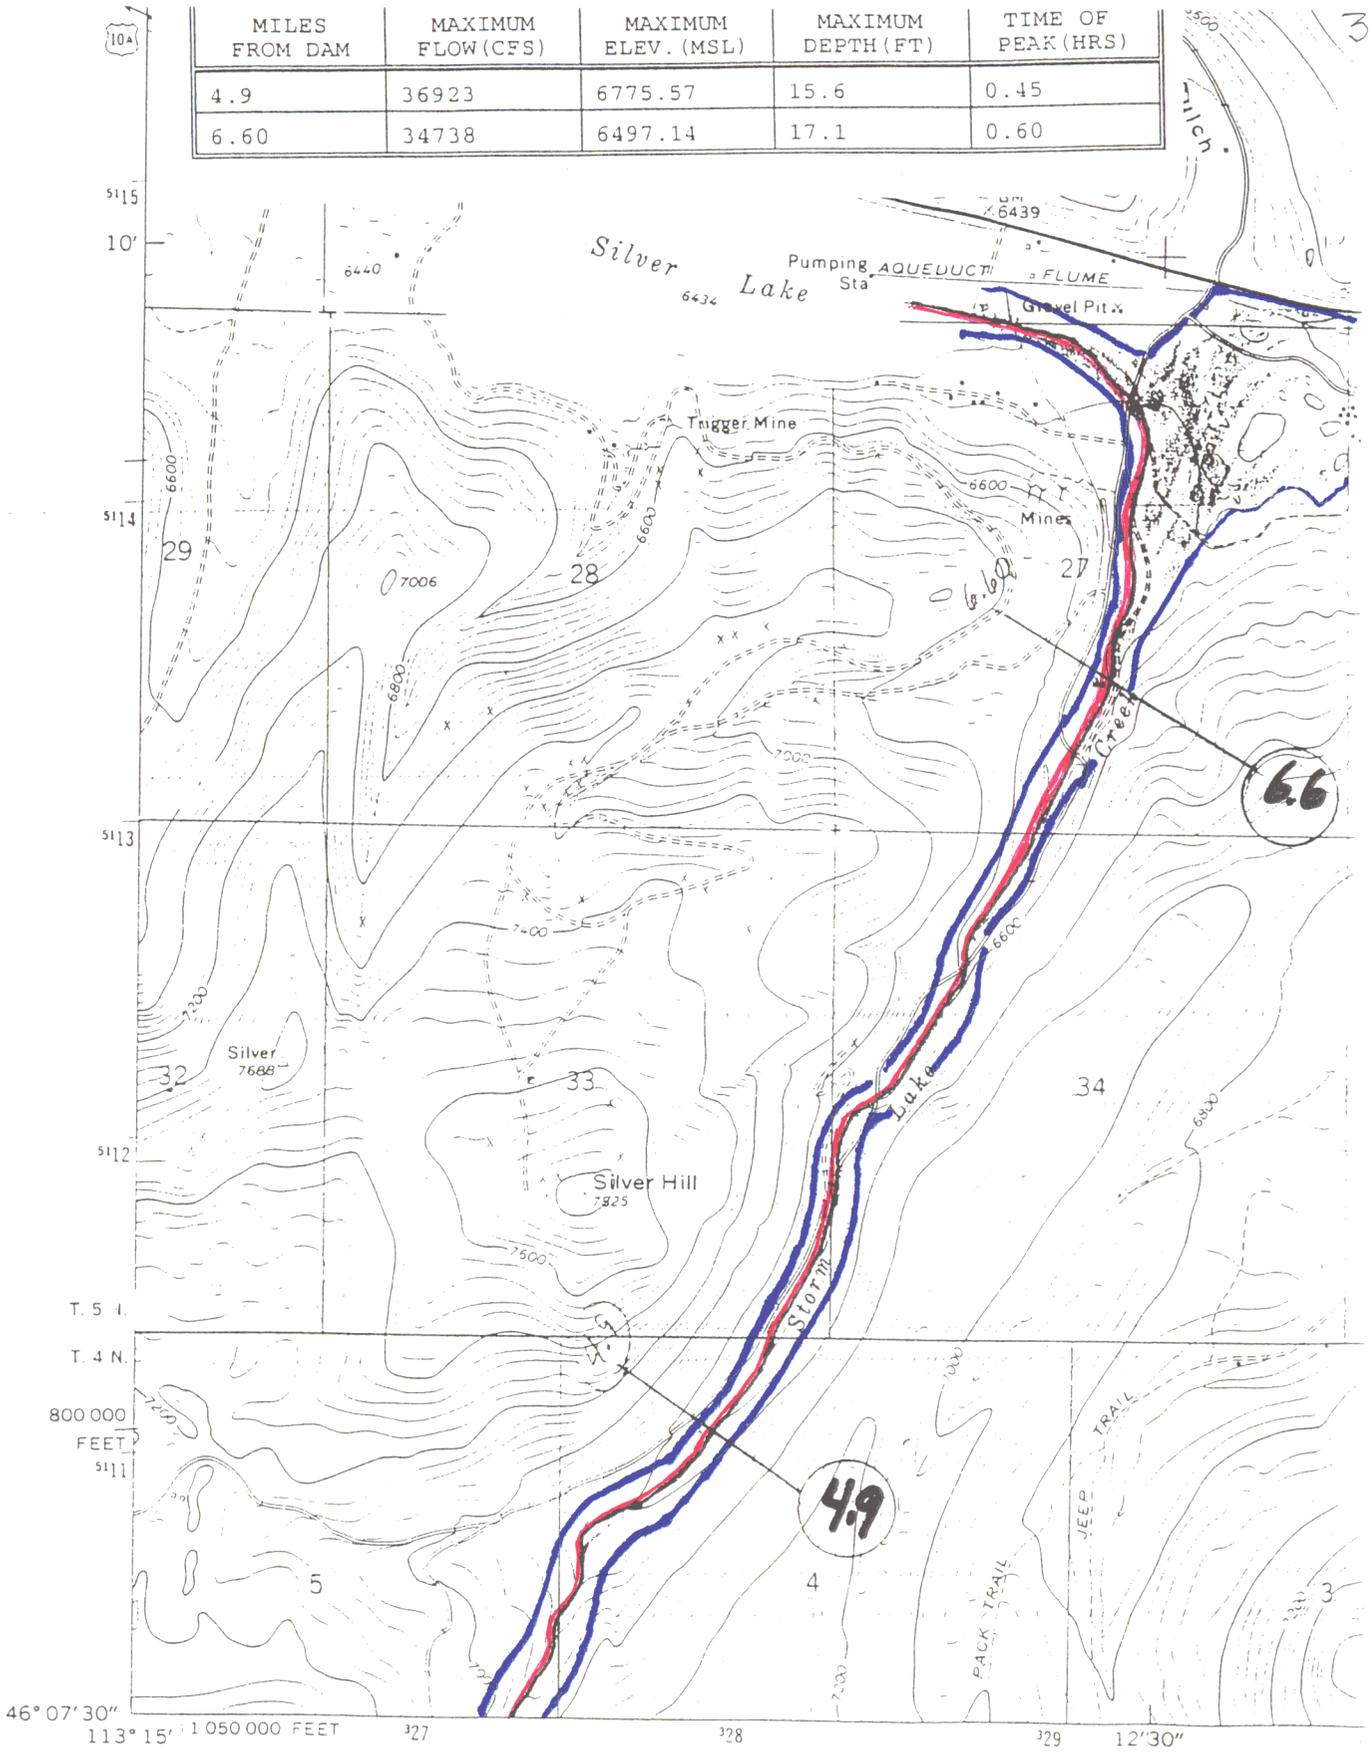
MILES FROM DAM	MAXIMUM FLOW (CFS)	MAXIMUM ELEV. (MSL)	MAXIMUM DEPTH (FT)	TIME OF PEAK (HRS)
4.9	36923	6775.57	15.6	0.45
6.60	34738	6497.14	17.1	0.60

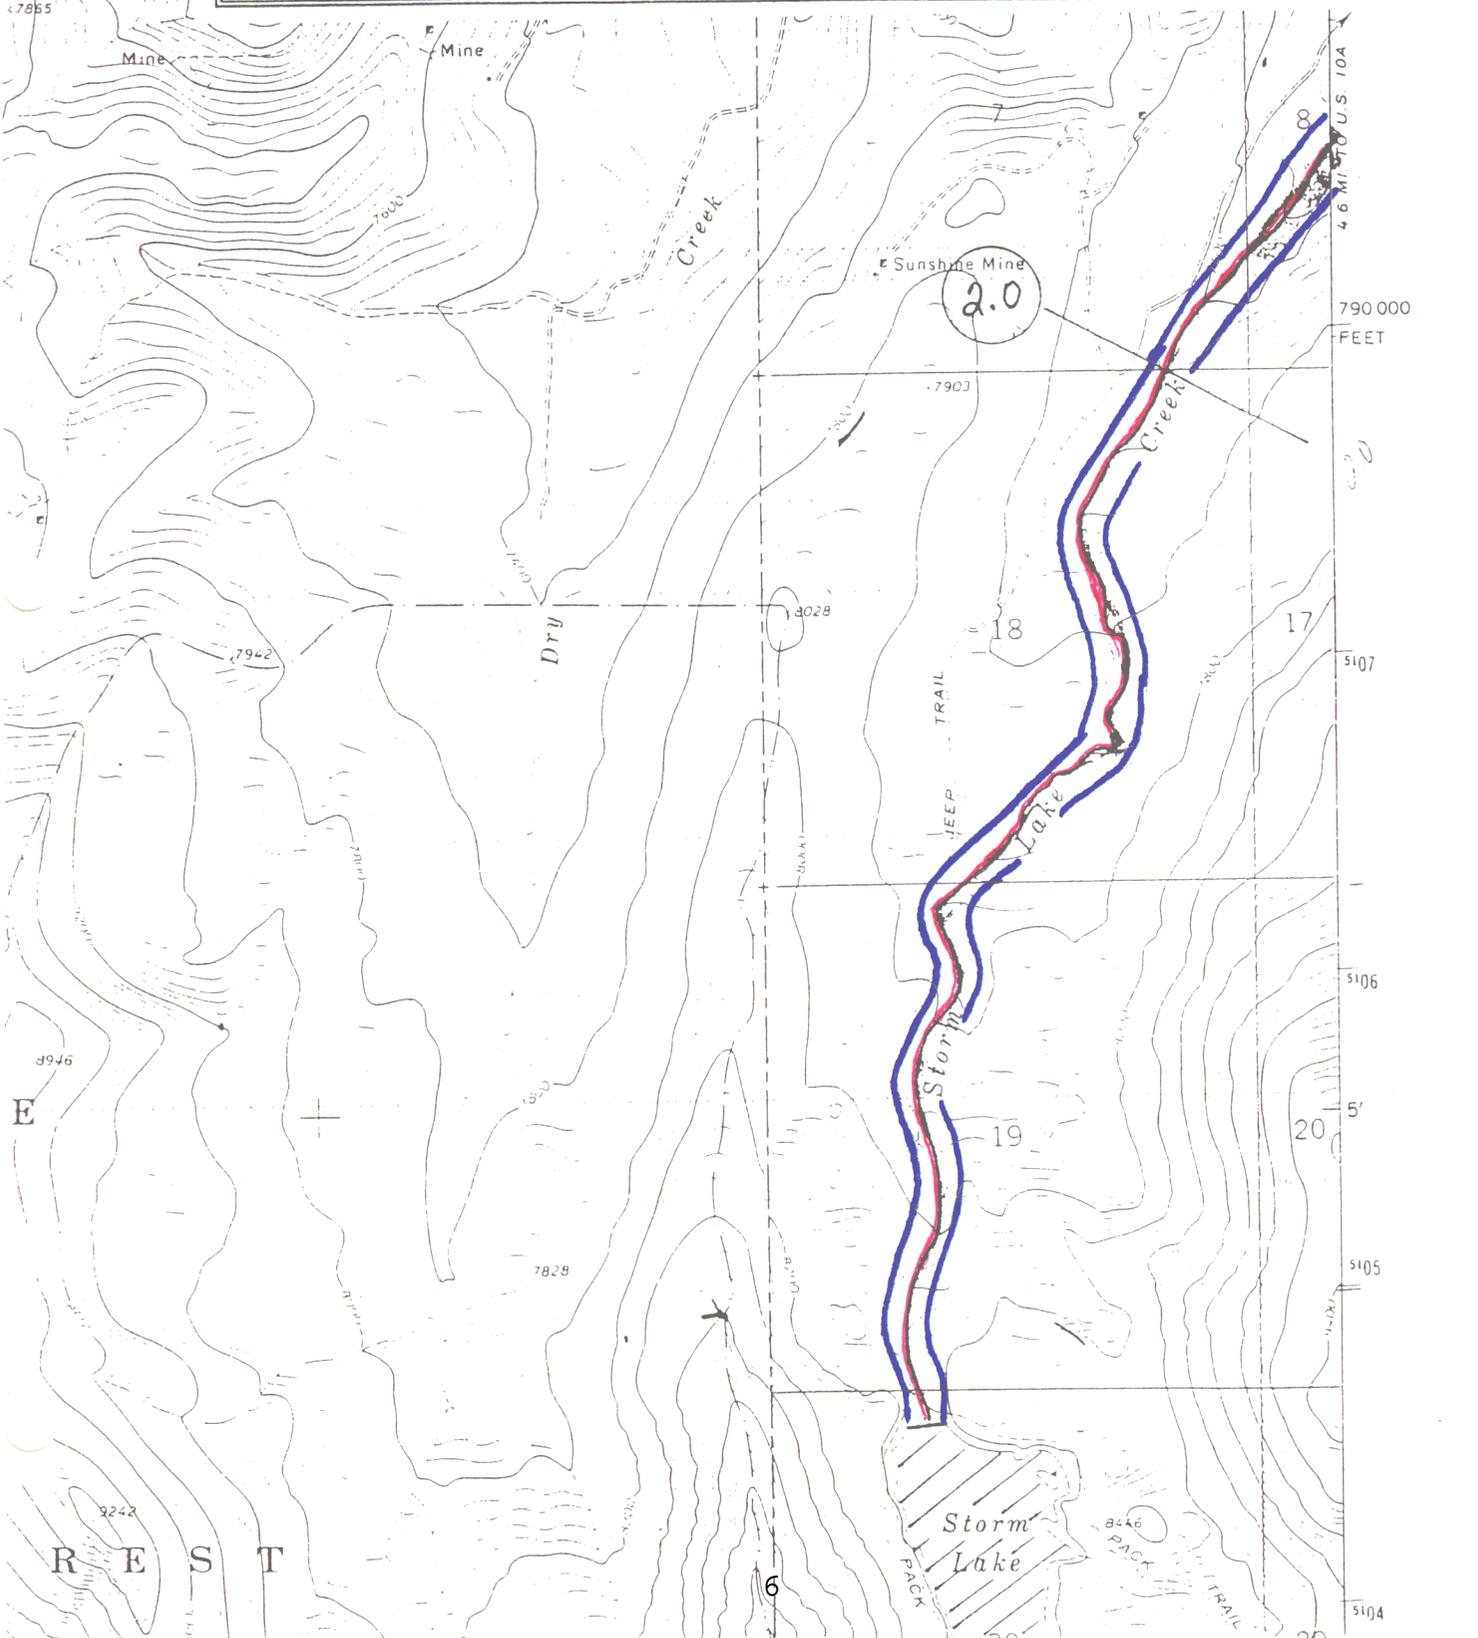
STORM INDUCED BREACH

MILES FROM DAM	MAXIMUM FLOW (CFS)	MAXIMUM ELEV. (MSL)	MAXIMUM DEPTH (FT)	TIME OF PEAK (HRS)
2.00	54083	7454.0	14.0	0.32

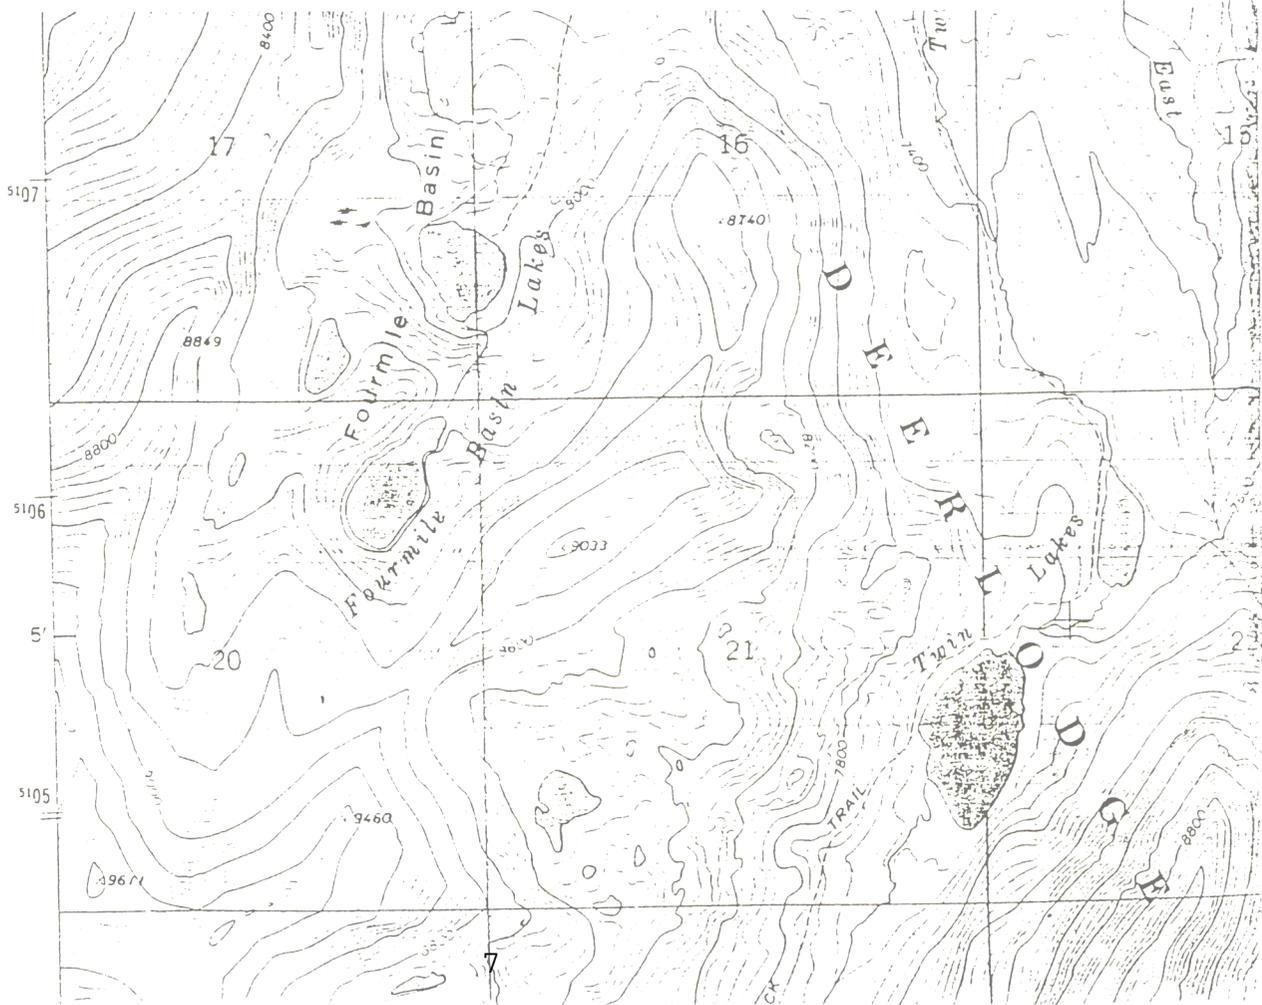
STORM INDUCED BREACH

MILES FROM DAM	MAXIMUM FLOW (CFS)	MAXIMUM ELEV. (MSL)	MAXIMUM DEPTH (FT)	TIME OF PEAK (HRS)
4.00	55123	7015.5	15.5	0.36

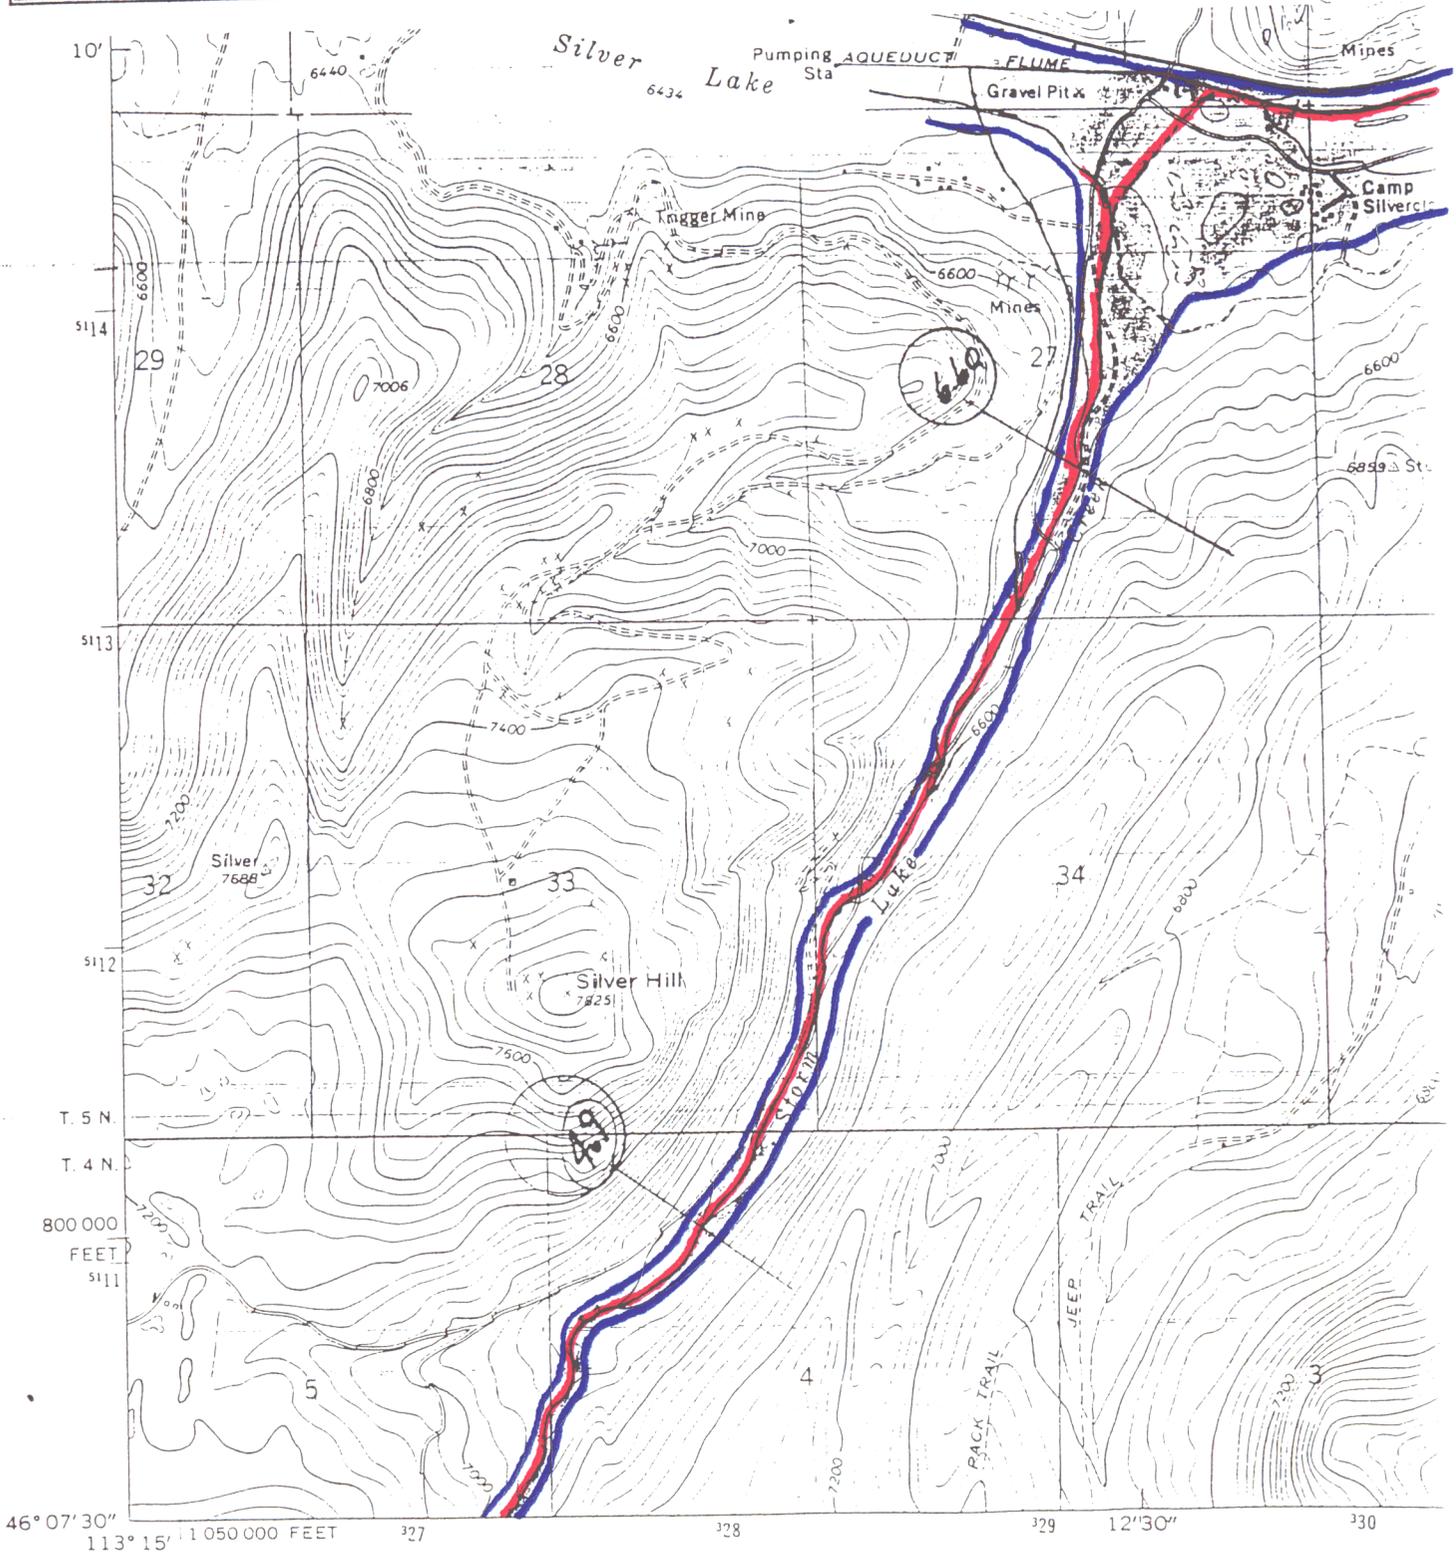
STORM INDUCED BREACH

MILES FROM DAM	MAXIMUM FLOW (CFS)	MAXIMUM ELEV. (MSL)	MAXIMUM DEPTH (FT)	TIME OF PEAK (HRS)
4.90	55748	6675.6	15.6	0.42
6.60	51921	6497.0	17.0	0.59

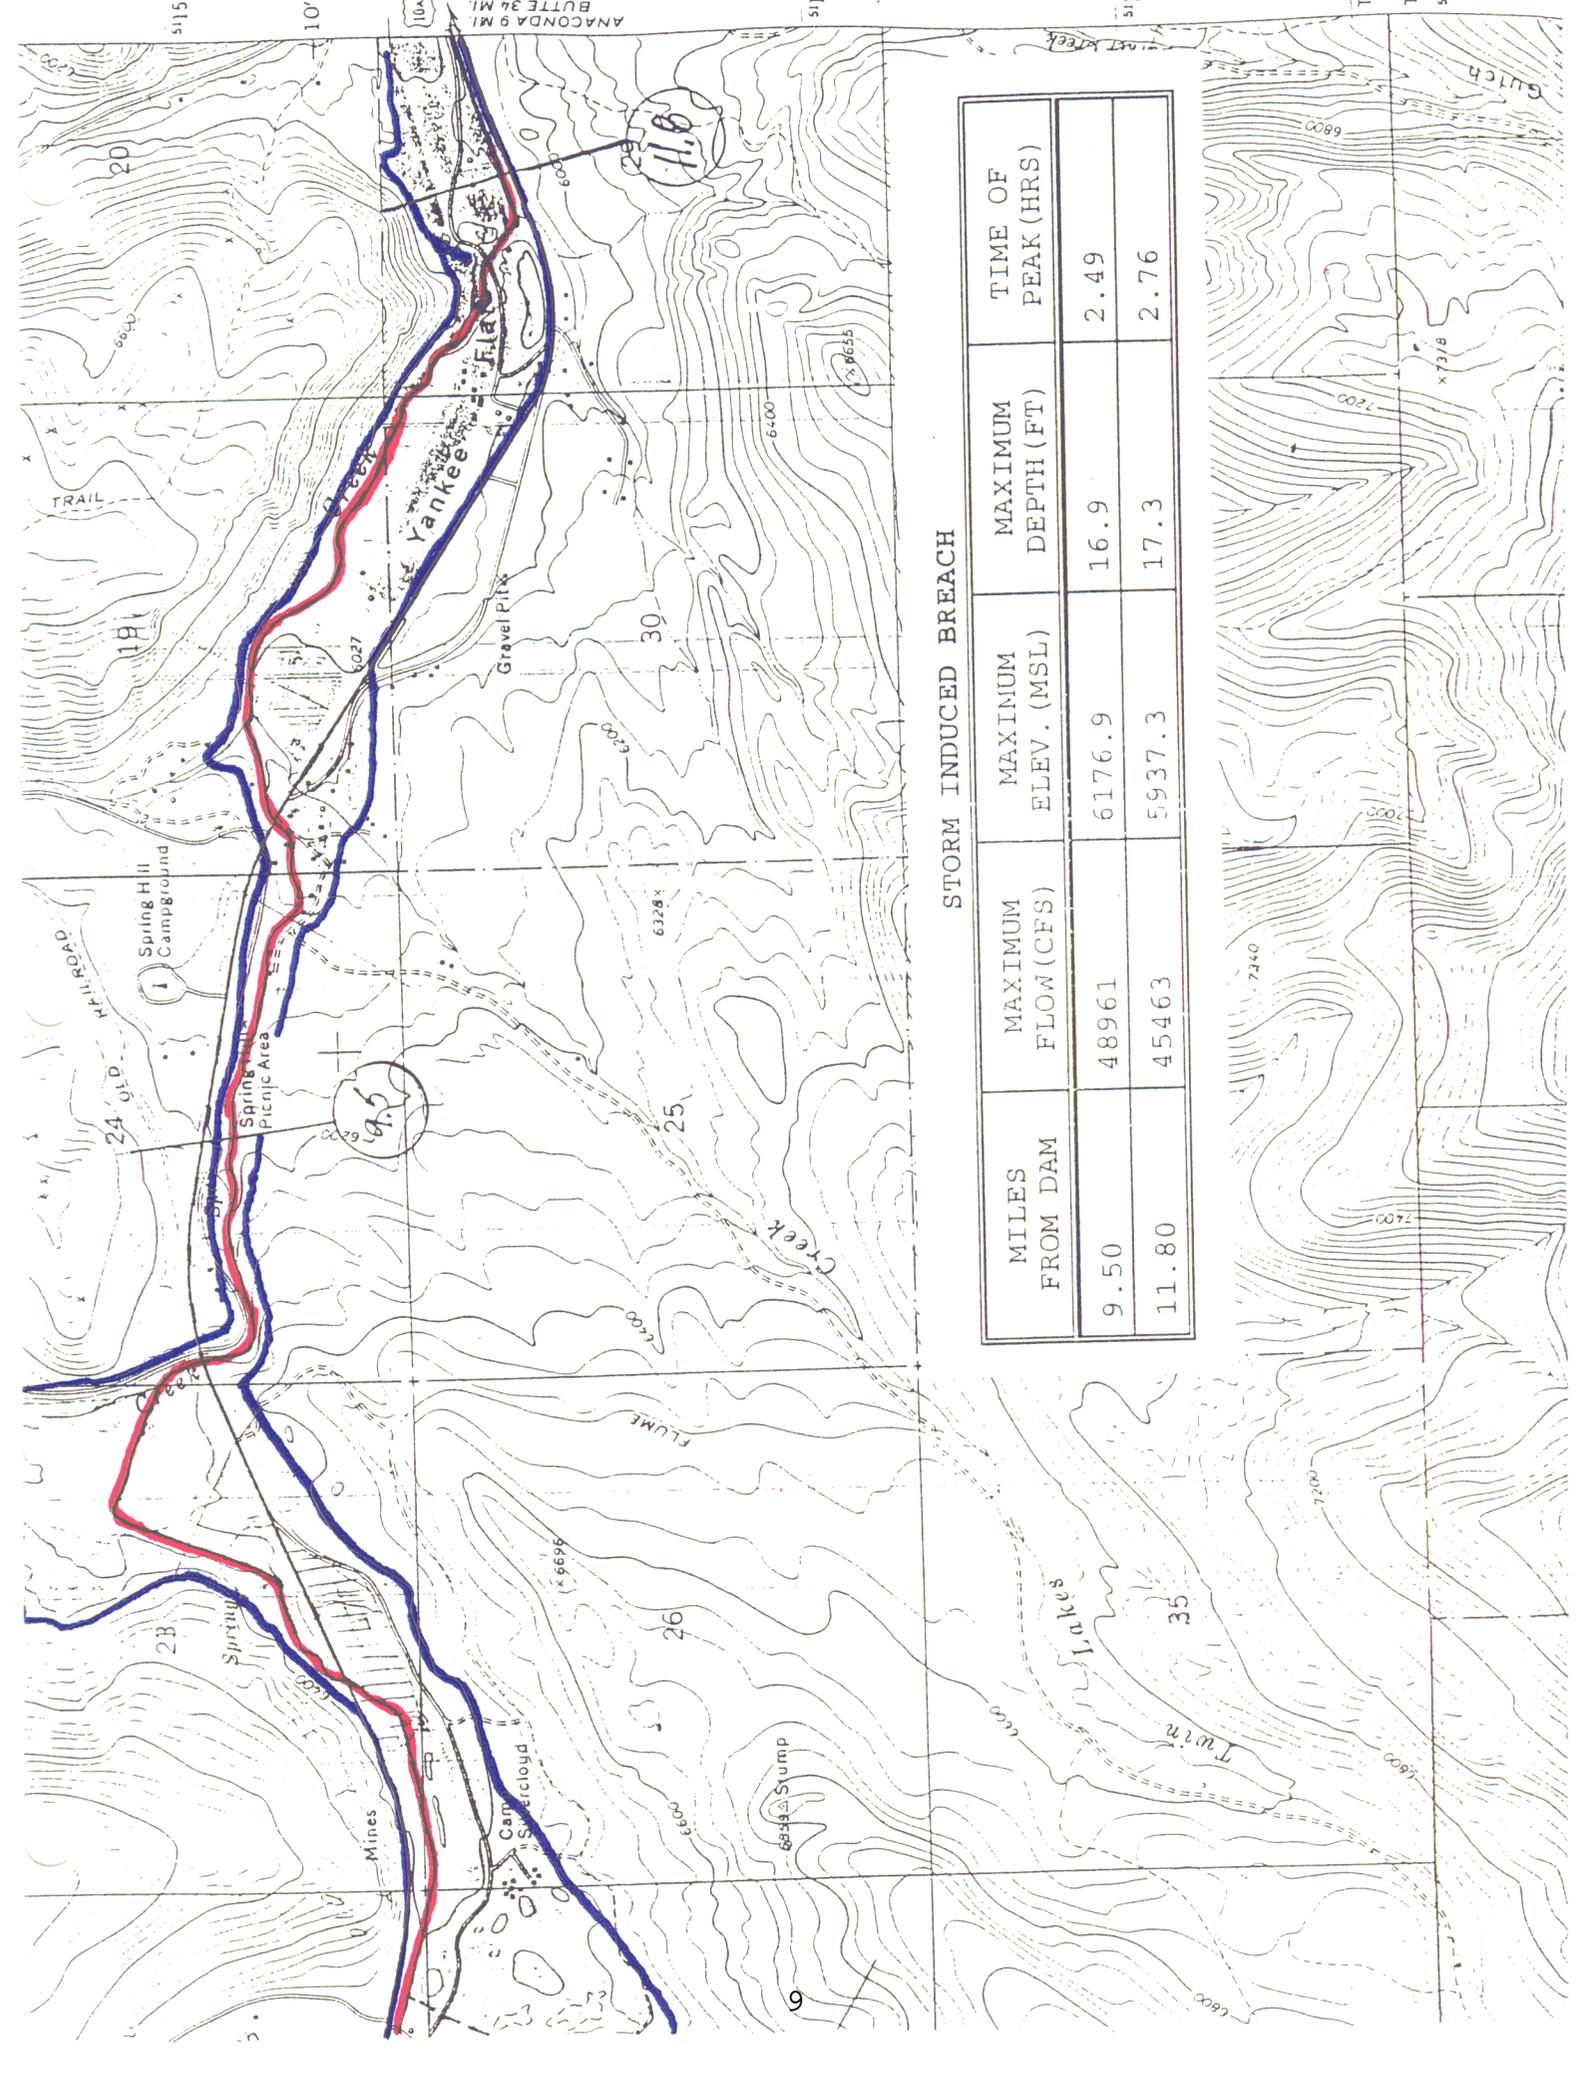
STORM INDUCED BREACH

MILES FROM DAM	MAXIMUM FLOW (CFS)	MAXIMUM ELEV. (MSL)	MAXIMUM DEPTH (FT)	TIME OF PEAK (HRS)
9.50	48961	6176.9	16.9	2.49
11.80	45463	5937.3	17.3	2.76

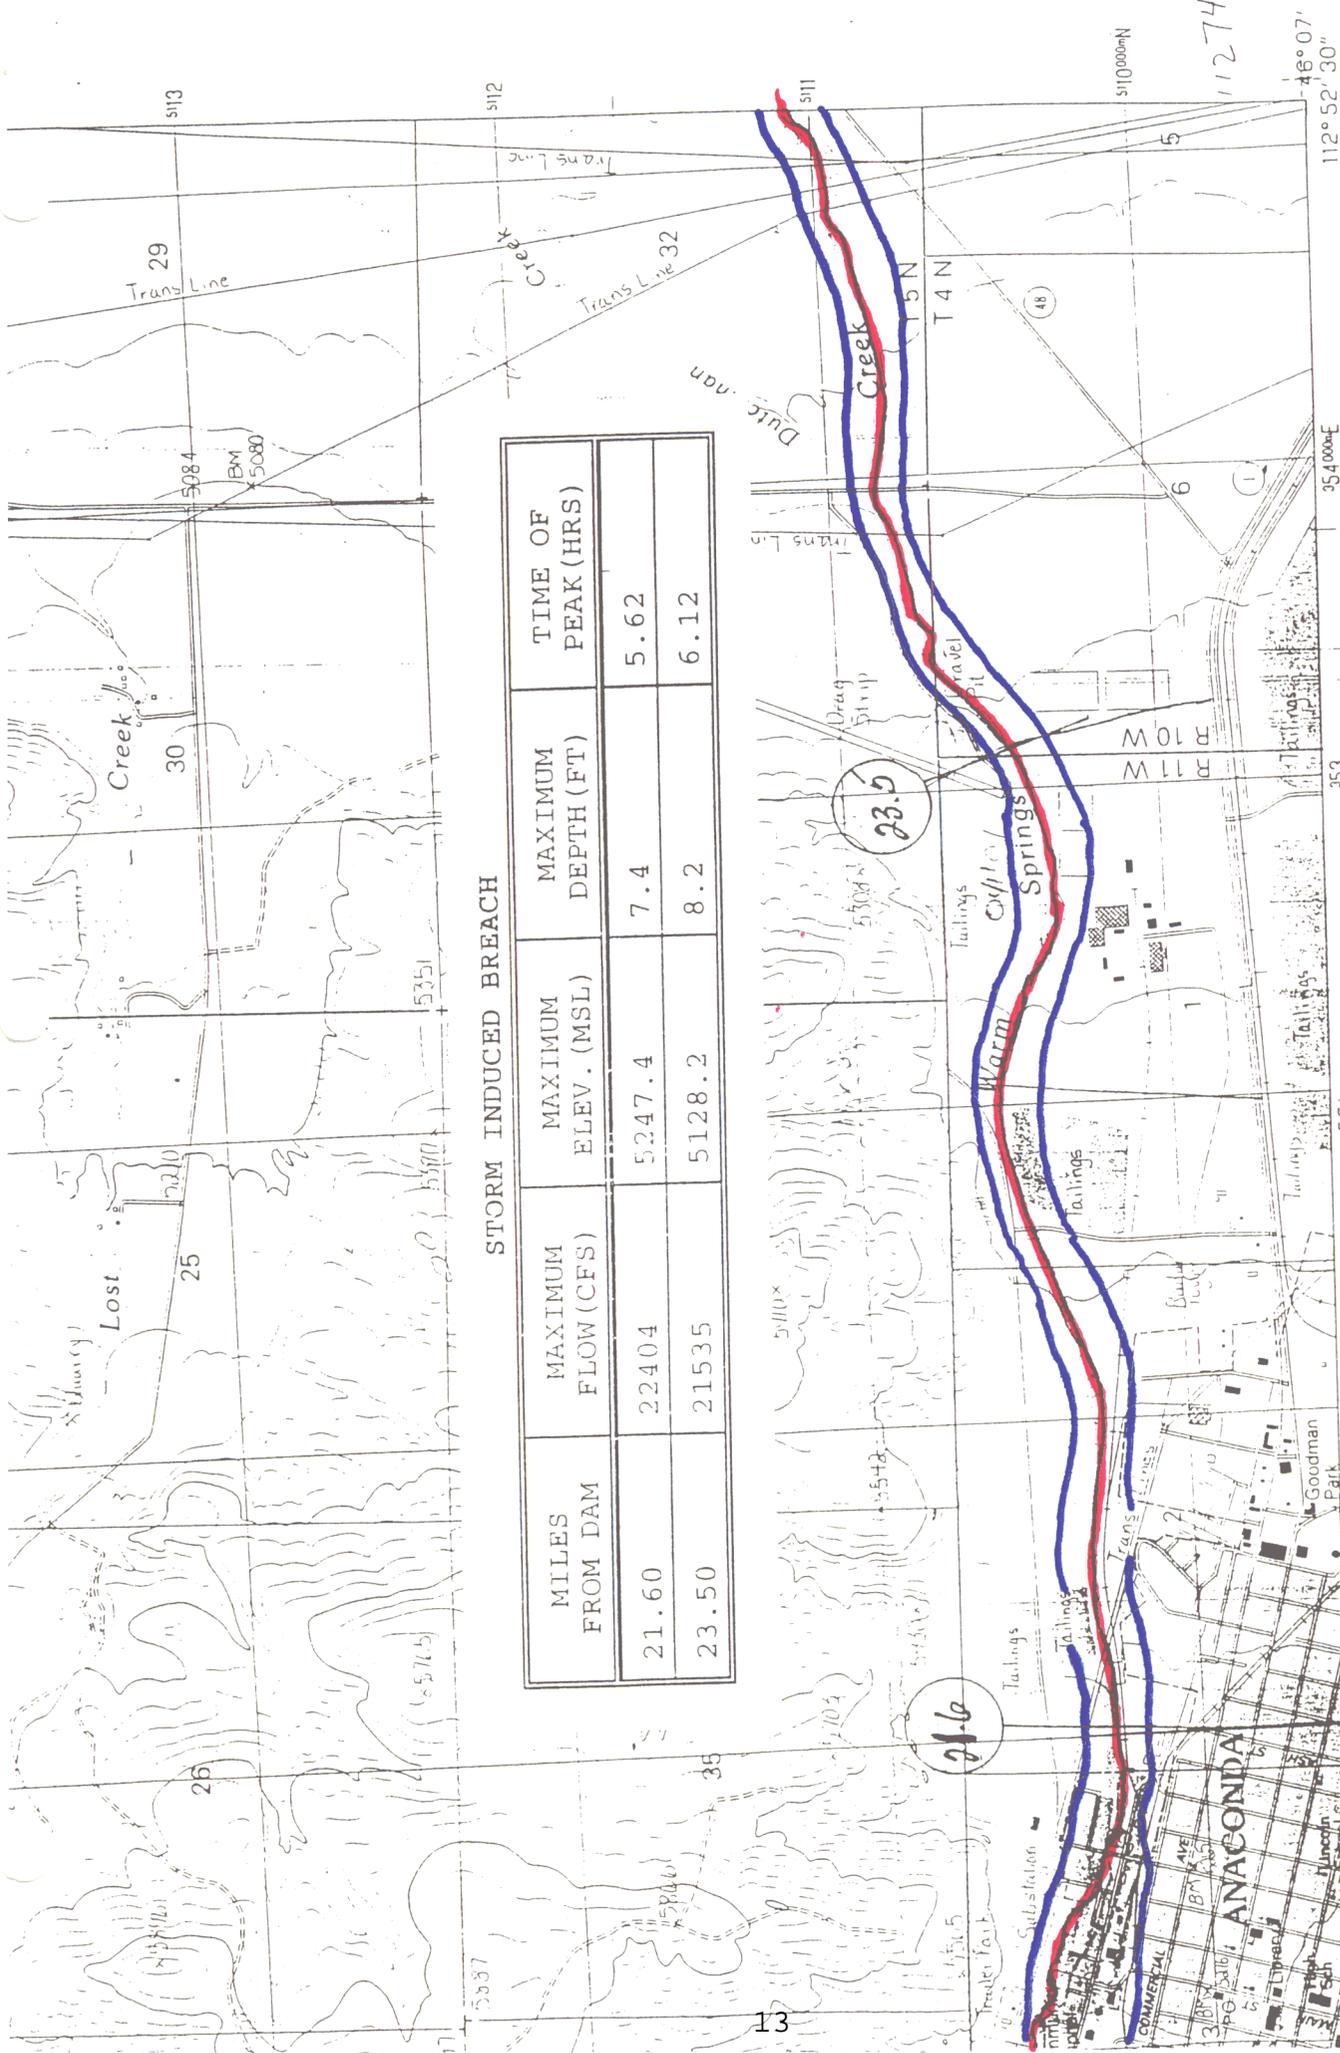
STORM INDUCED BREACH

MILES FROM DAM	MAXIMUM FLOW (CFS)	MAXIMUM ELEV. (MSL)	MAXIMUM DEPTH (FT)	TIME OF PEAK (HRS)
21.60	22404	5247.4	7.4	5.62
23.50	21535	5128.2	8.2	6.12
